Oregon State University Utility Pole Research Cooperative (UPRC)

**Department of Wood Science & Engineering
38th Annual Report
2018**

**By:
Jed Cappellazzi and Matt Konkler**

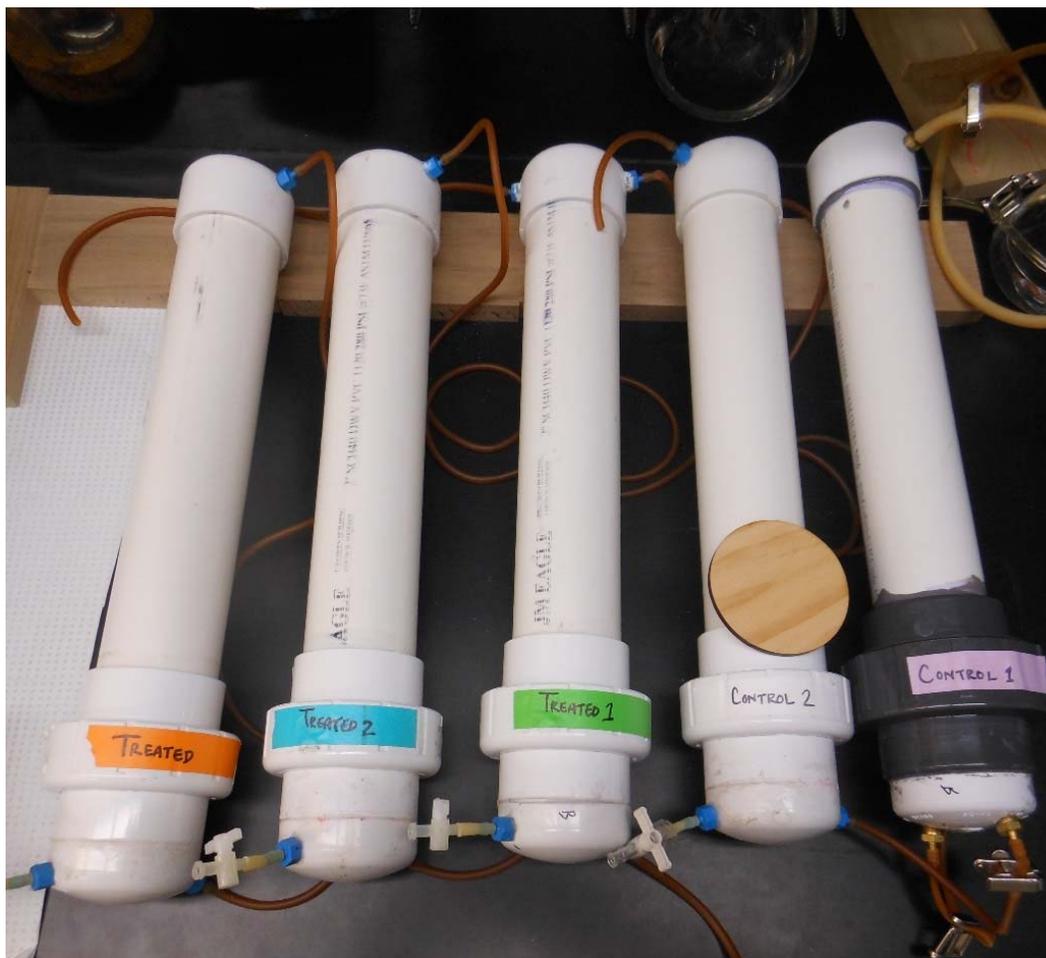
Figure I-1. Photograph of five of the diffusion apparatuses used to assess boron movement through non-treated or diesel oil-treated Douglas-fir lumber. A 25 mm diameter wood sample is resting on the fourth chamber to provide a measure of scale.

Non-treated and oil treated discs were then inserted in a diffusion apparatus constructed using 100 mm diameter PVC piping with one chamber on either side of the disk. The disc was held in place using a threaded connector that effectively sealed each chamber so that any movement would have to occur through the wood. One chamber contained a 4% boric acid equivalent (BAE) solution, while the other contained distilled water. Each chamber had a sampling port that allowed for solution to be removed for analysis of boron concentration (Figure I-1).

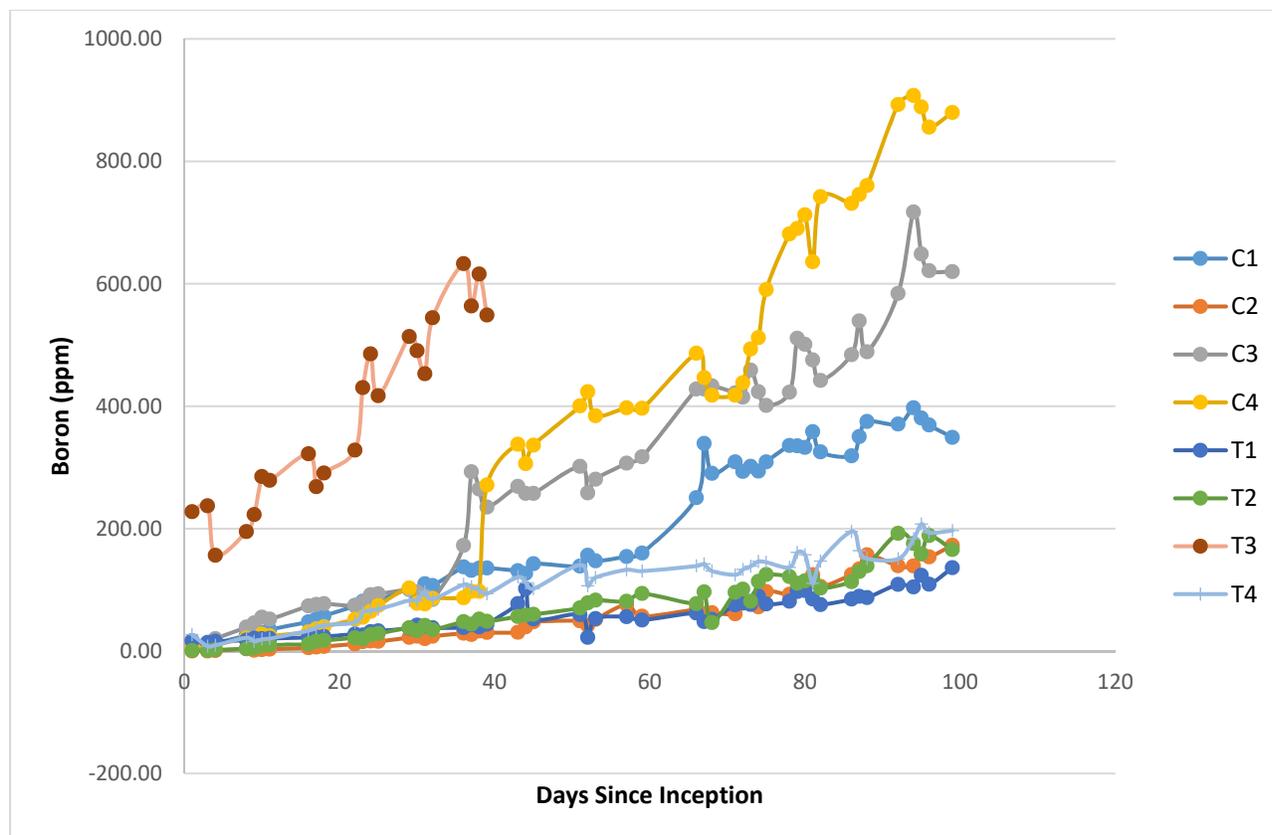
Figure I-2. Boron concentrations on the receiving end of diffusion tests using radially oriented Douglas-fir sapwood with or without a biodiesel treatment where C= no treatment and T= diesel treated samples. The T-3 sample developed a leak and was dropped from the test.

Two years ago, we reported on tests that included radially oriented specimens with and without diesel treatment. The experiment was monitored on a regular basis for over 100 days. Boron movement was initially limited in both treated and control samples, but concentrations in control samples with no oil treatment increased at a much more rapid rate after 40 days of exposure (Figure I-2). Concentrations on the receiving ends of control samples have continued to increase at a much faster rate than treated samples. This trial was discontinued because leaks in several chambers led to concerns about spurious results.

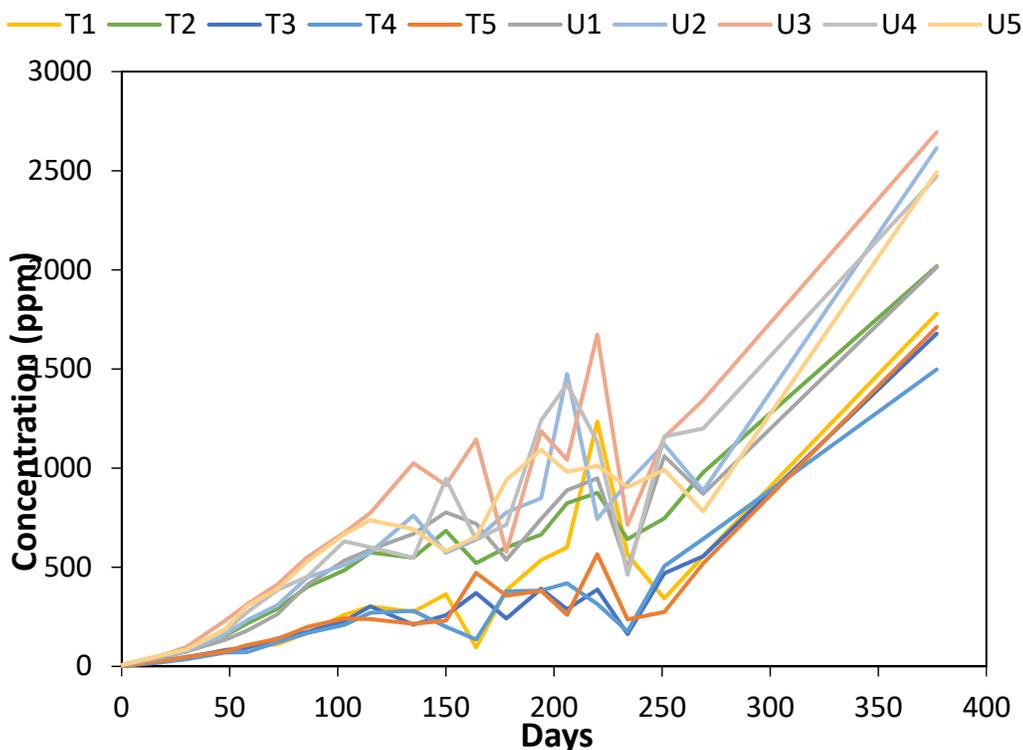
Boron Diffusion as a Function of Time

Figure I-3. Boron concentrations vs time on the receiving end of diffusion tests using radially oriented Douglas-fir sapwood with (T samples) or without a biodiesel treatment (U samples).

A second test was established last year using a similar set up but with better seals. This test has been monitored for 375 days before leaks developed and the test was terminated (Figure I-3). Boron was detected on the receiving (distilled water) side of the chambers within 25 days in chambers containing either treated or non-treated samples, although levels detected were higher in chambers with untreated samples. Boron levels continued to increase with time in both sets of chambers; however, boron concentrations increased much more rapidly in chambers with untreated wood. Initially,

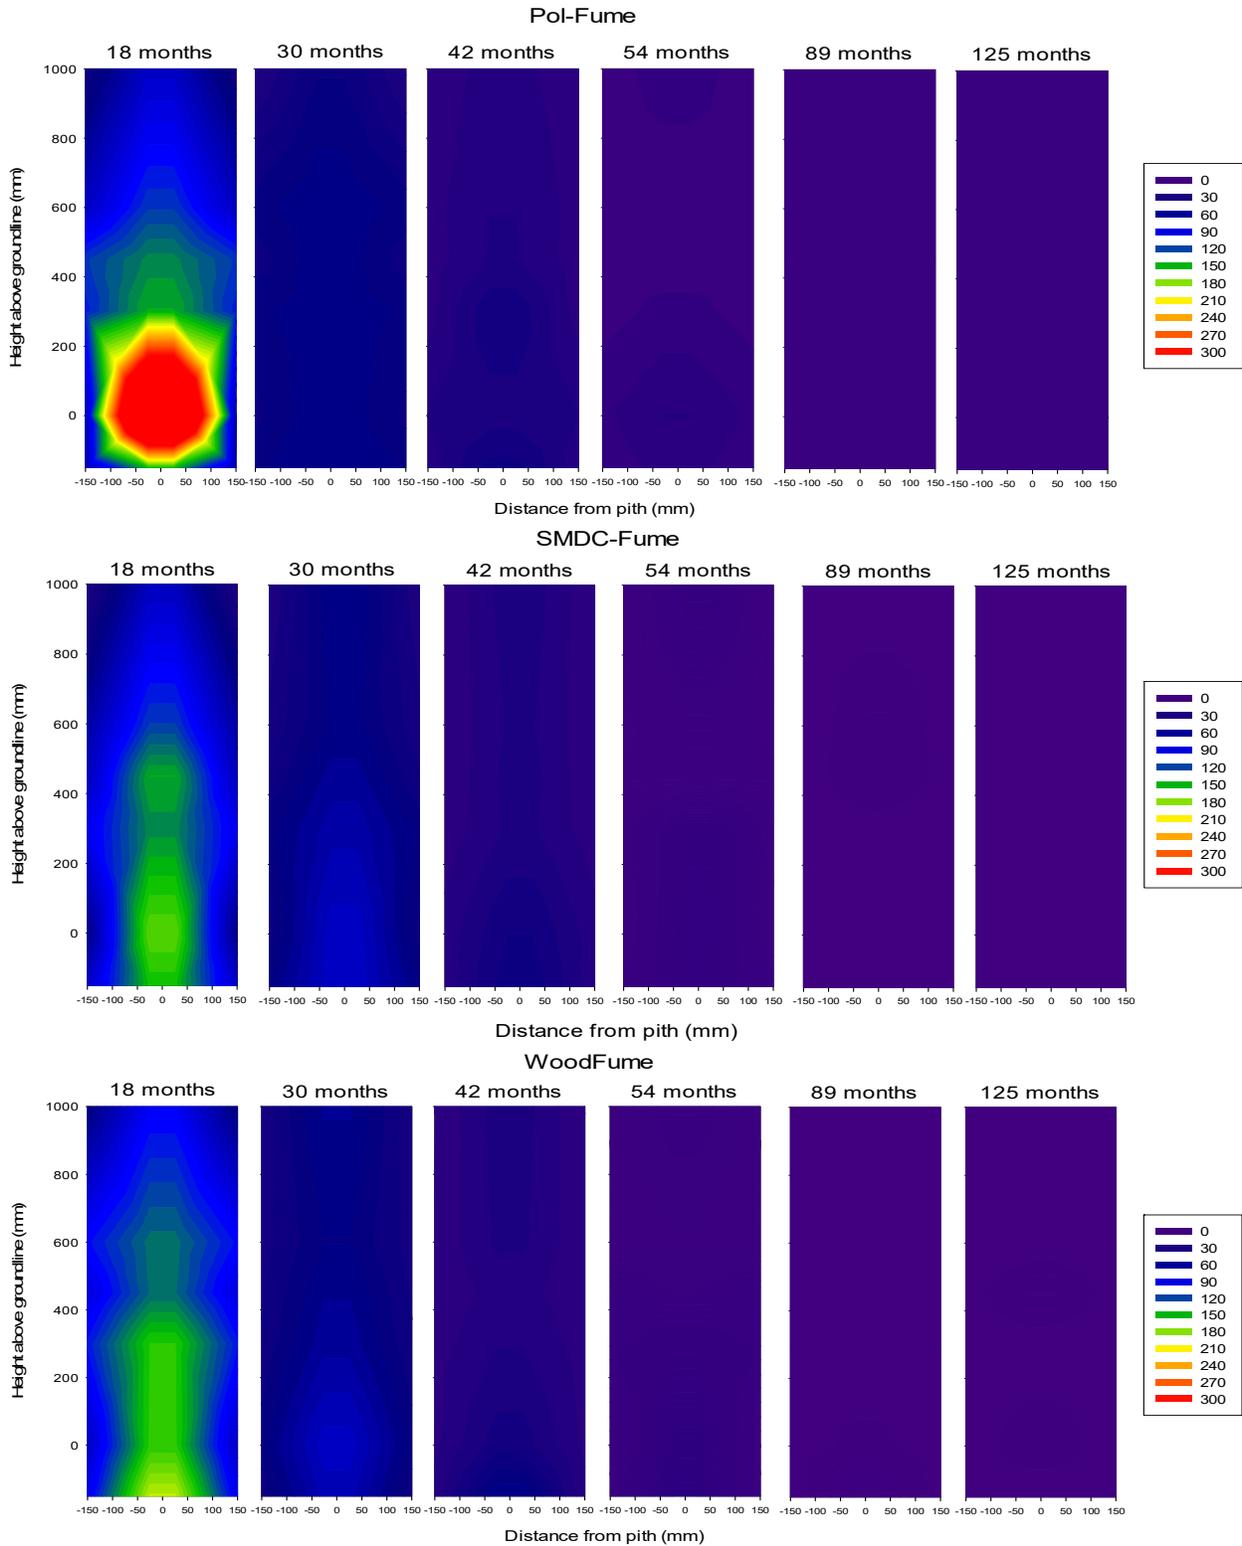
Figure I-4. Distribution of MITC in Douglas-fir pole sections 18 to 125 months after treatment with Pole Fume, SMDC Fume or Wood-Fume. Dark blue signifies little or no chemical while increasingly light blue to green or yellow signifies MITC levels above the threshold. Charts are extrapolated from individual MITC analyses at assay locations described in Table I-3.

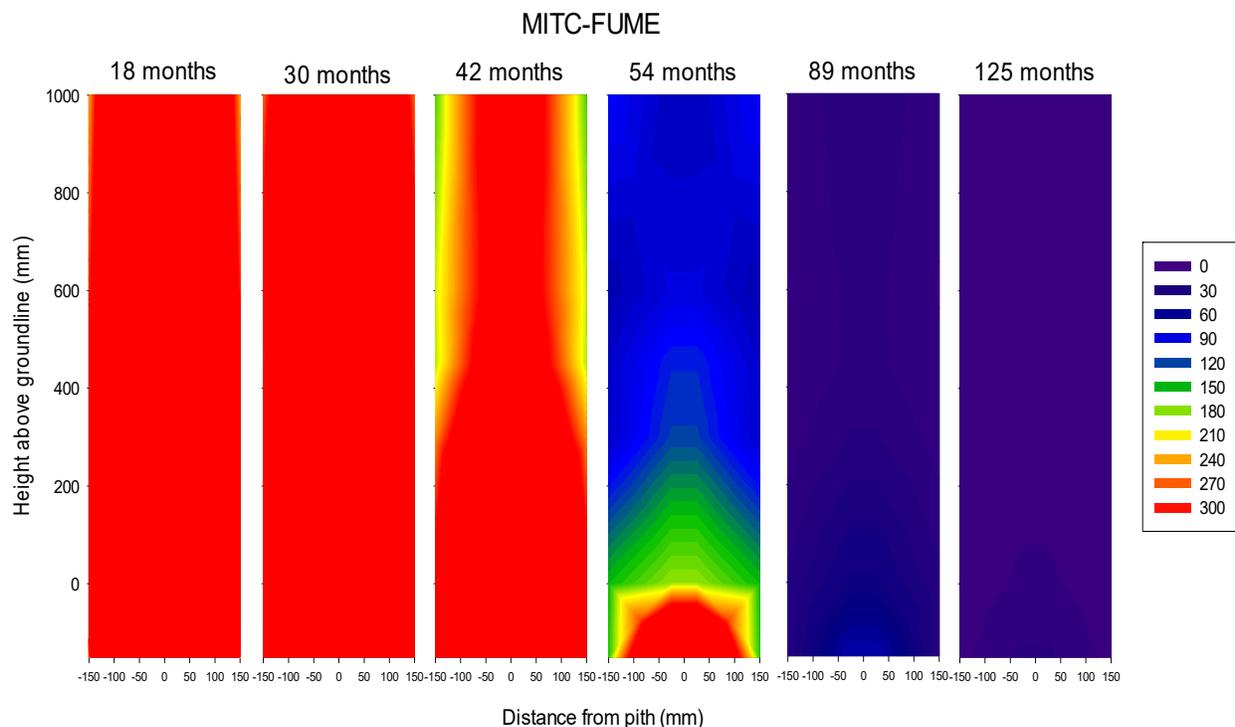
Figure I-5. Distribution of MITC in Douglas-fir pole sections 18 to 125 months after treatment with MITC-Fume. Dark blue signifies little or no chemical while increasingly light blue to green or yellow signifies MITC levels above the threshold. Charts are extrapolated from individual MITC analyses at assay locations described in Table I-3.

MITC-FUME treated poles contained the highest MITC levels of any product 18-months after treatment, approaching 100 times the threshold 150 mm below and 300 mm above groundline. MITC levels have declined steadily since that time, but were still well above the threshold for protection against fungal attack 54 months after treatment (Figure I-5). For example, MITC levels in the inner zones of cores removed 150 mm below groundline averaged 612 µg/g of wood, over 30 times the threshold at 54 months. MITC levels at other locations are somewhat lower, but are still three to nine times threshold. MITC levels in poles 89 months after treatment had declined sharply from those at 54 months. While the levels were above the threshold at or below groundline, MITC levels above ground were no longer protective. MITC levels after 125 months were mostly below threshold for fungal protection, indicating retreatment would be advisable. These results illustrate the excellent properties of this treatment and are consistent with the original field trials showing protective levels remained in Douglas-fir poles 7 years after treatment. These results indicate MITC-FUME would easily provide protection against renewed fungal attack for 10 years based upon the time required for fungi to begin reinvading fumigant-treated poles.

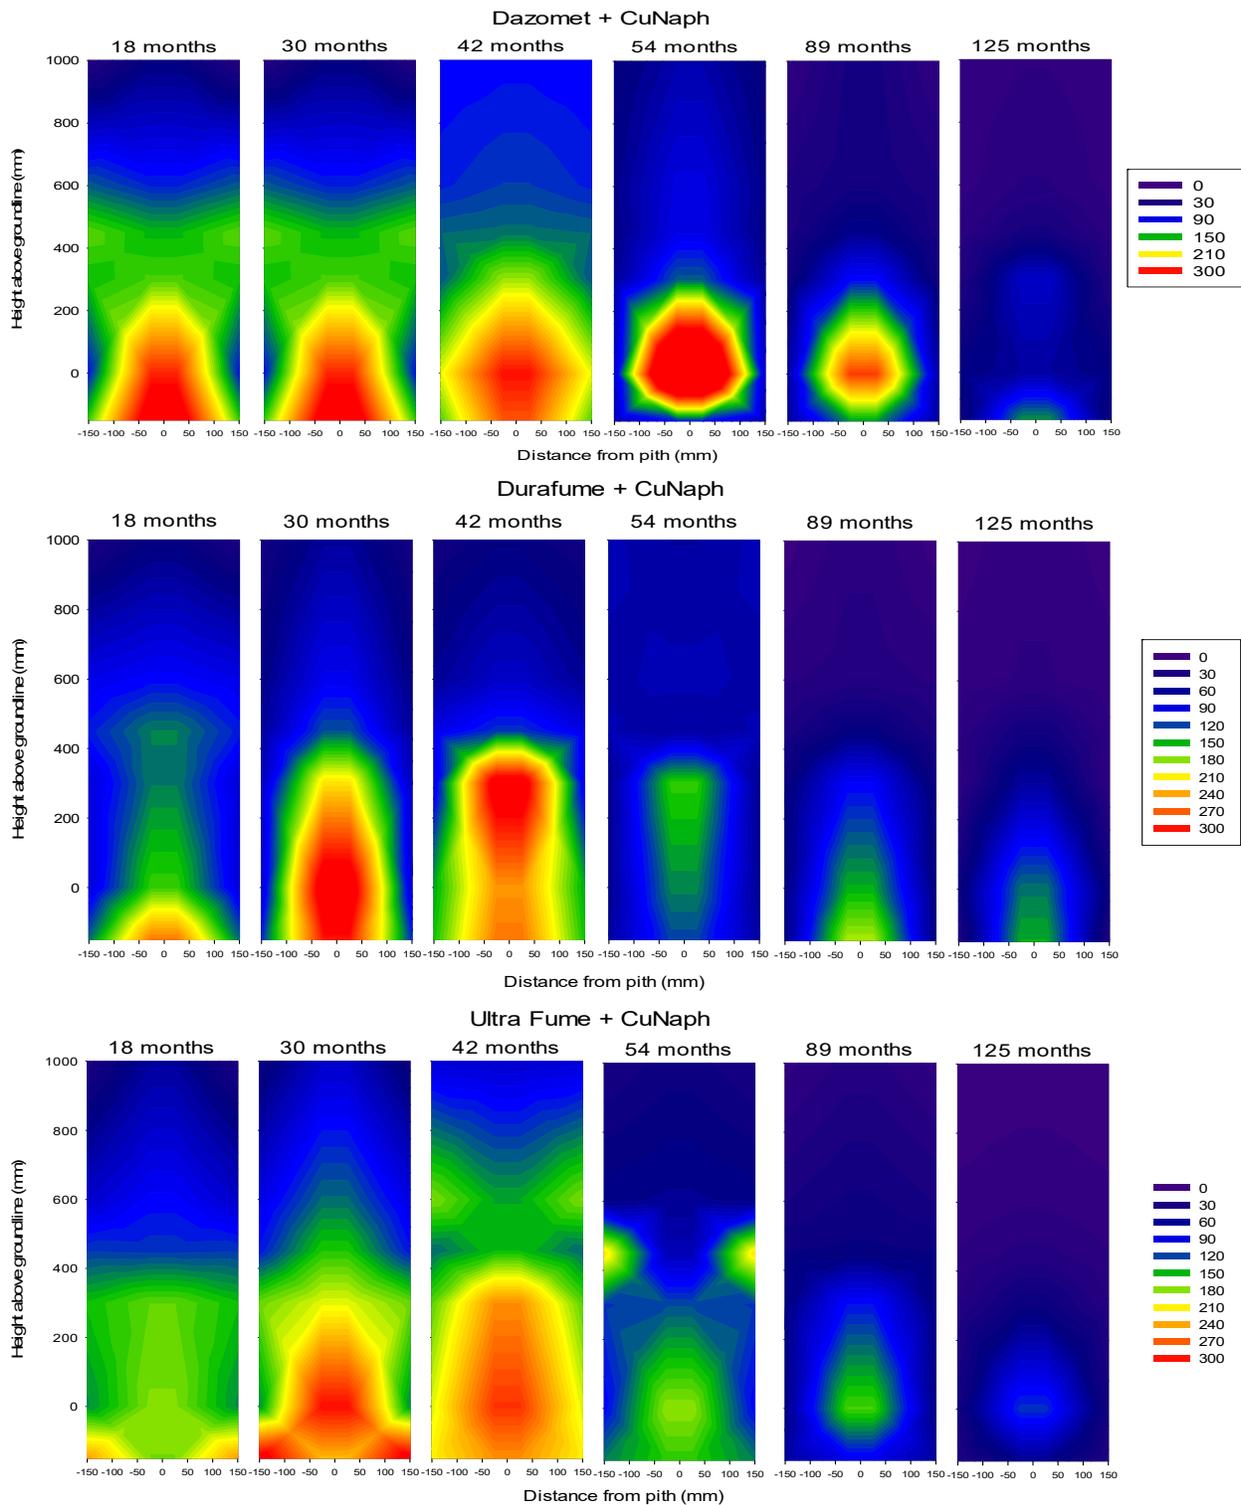
Figure I-6. Distribution of MITC in Douglas-fir pole sections 18 to 125 months after treatment with dazomet, DuraFume, or UltraFume plus copper naphthenate. Dark blue signifies little or no chemical while increasingly light blue to green or yellow signifies MITC levels above threshold. Charts are extrapolated from individual MITC analyses at assay locations described in Table I-3.

after treatment were still above the threshold at all sampling locations, but the overall levels had declined by 30 to 50% over the 12 month interval (Figure I-6). MITC levels after 54 months were still 3 to 11 times above the minimum threshold, and, as in previous trials, we have observed periodic surges in MITC levels in dazomet-treated poles. We have attributed these increases to periods of elevated rainfall that increased wood moisture content, thereby enhancing residual dazomet decomposition in the treatment holes. It is impossible to predict whether this will occur during our testing, but MITC levels do remain adequate to provide protection against fungal attack in all dazomet treatments. MITC levels 89 months after application of the three dazomet systems were above threshold from below groundline to 600 mm above groundline. Overall levels continued to decline but MITC concentrations remained 3 to 6 times threshold at many locations. MITC levels in poles 125 months after treatment remain above threshold 300 mm below ground to 300 mm above the zone. MITC levels were more variable above that level, but many areas still contained protective levels of chemical. These results are also consistent with previous field trials and indicate this system will provide at least the 10 year protective period used by most utilities in their inspection and treatment cycles. There also appeared to be little difference in performance between dazomet treatments.

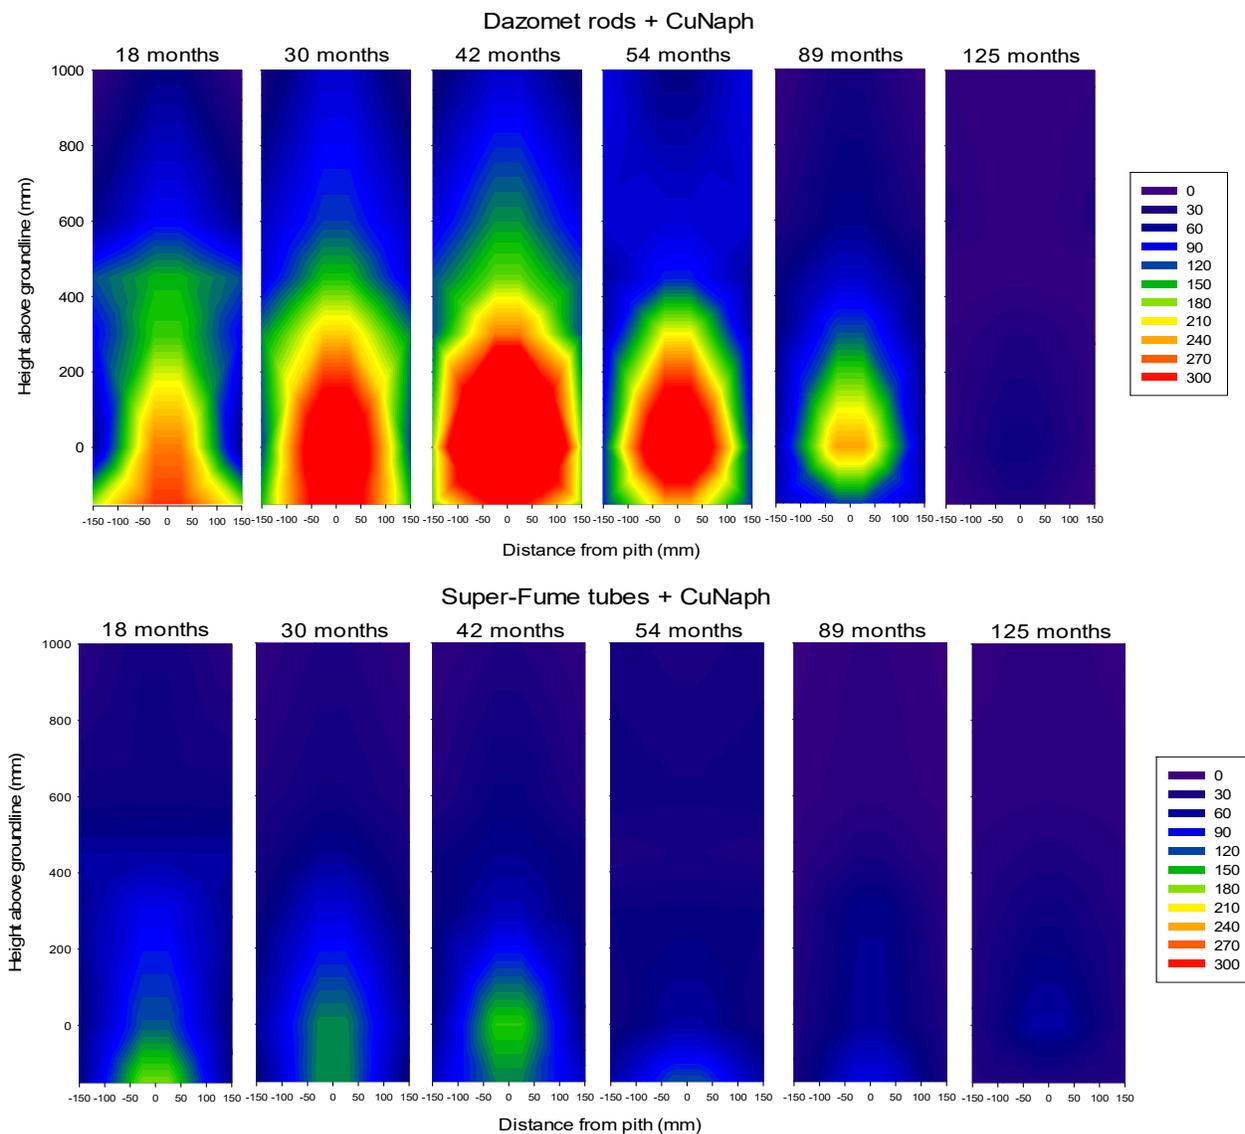
Figure I-7. Distribution of MITC in Douglas-fir pole sections 18 to 125 months after treatment with dazomet rods or Super-Fume tubes plus copper naphthenate. Dark blue signifies little or no chemical while increasingly light blue to green or yellow signifies MITC levels above the threshold. Charts are extrapolated from individual MITC analyses at assay locations described in Table I-3.

MITC levels in poles receiving either dazomet in rod form or in tubes (Super-Fume tubes) tended to be lower than levels found in poles receiving powdered treatments, but were still above the threshold at all sampling points below groundline and up to the 900 mm above groundline. Chemical levels near the surface at 900 mm were more variable than in the powdered treatments (Figure I-7). The rods and tubes both may restrict contact between the wood and the chemical, creating the potential for reduced decomposition. There were negligible differences in MITC levels between poles receiving powdered or rod dazomet for most of the test. The tubes appeared to have a greater effect on MITC levels, with consistently lower MITC levels than the other dazomet based systems; however, levels remained 1.5 to 6 times threshold at 54 months at all sampling locations. These results indicate that, while the tubes slow MITC release, this does not result in chemical levels below threshold at 54 months. The results at 89 months indicated MITC levels continued to decline in poles treated with either the rod or the tube system. MITC levels were still above the threshold up to 300 mm above groundline, then declined below threshold higher up the poles. As in previous inspections, MITC levels were slightly lower in poles receiving tubes than rods. Dazomet rods produced MITC levels that were similar to those found with powder for the first 54 months. MITC levels after that time were slightly lower in poles receiving either rods or tubes and were approaching threshold at 125 months. Results indicate dazomet rod or tube systems would provide 10 year inspection cycle protection.

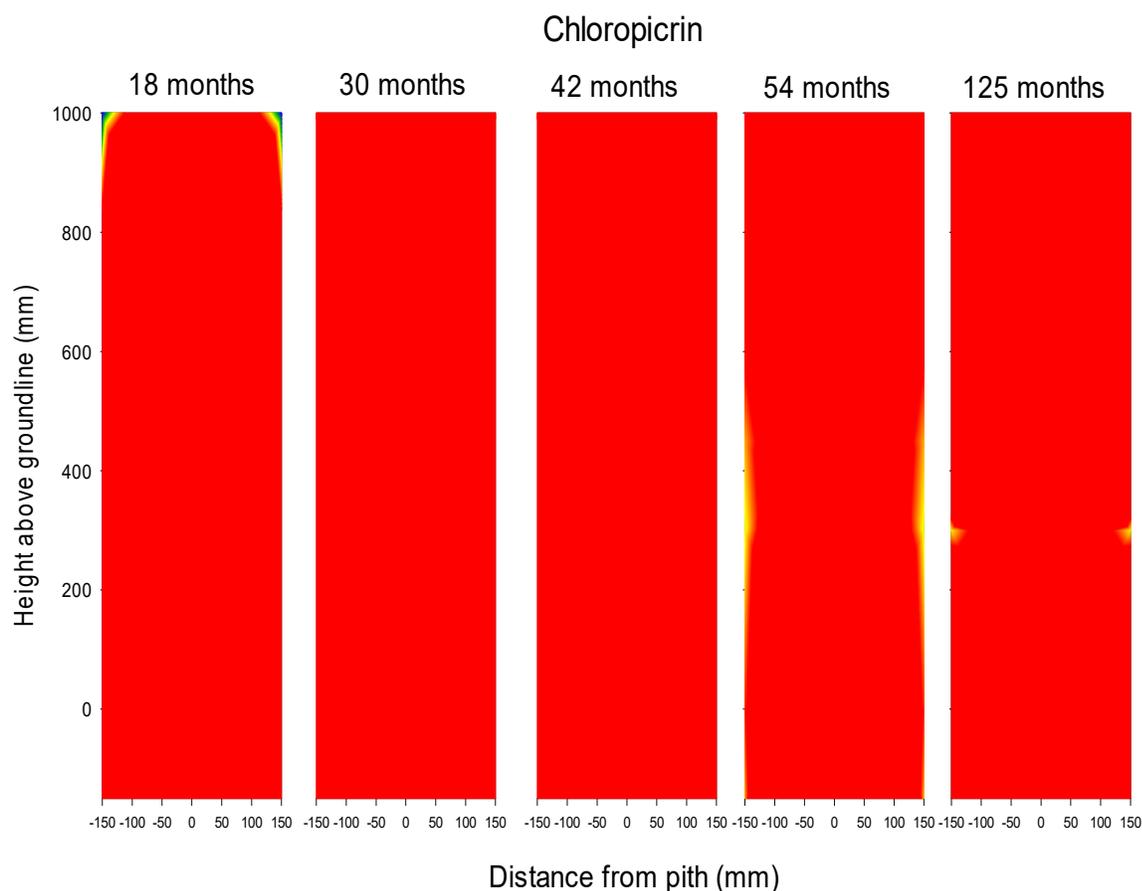
Figure I-8. Distribution of chloropicrin in Douglas-fir pole sections 18 to 54 months after treatment with TimberFume. Red indicates chloropicrin levels multiple times over threshold. Charts are extrapolated from individual chloropicrin analyses at assay locations described in Table I-3.

Levels declined marginally 30 months after treatment, but remained extremely high. Chloropicrin levels appeared to increase at the 42 month evaluation, but a re-examination of the data revealed that the levels reported in the 2012 annual report were approximately double the actual value. The revised values continue to show a steady decline at the 42 month point, but chloropicrin levels remained 17 to 350 times threshold. Chloropicrin retentions 54 months after treatment declined further, but remained 13 to 100 times threshold (Figure I-8). Chloropicrin was not analyzed in the 89 month sampling, but was analyzed after 125 months. Chemical levels were 10 to 150 times threshold, with lower levels further above groundline. Most levels were 50 to 100 times threshold. Unlike MITC, chloropicrin has strong chemical interactions with wood which results in much longer residual times. We have found detectable chloropicrin in poles 20 years after treatment and the results in the current study are consistent with a long residual protective period for this fumigant.

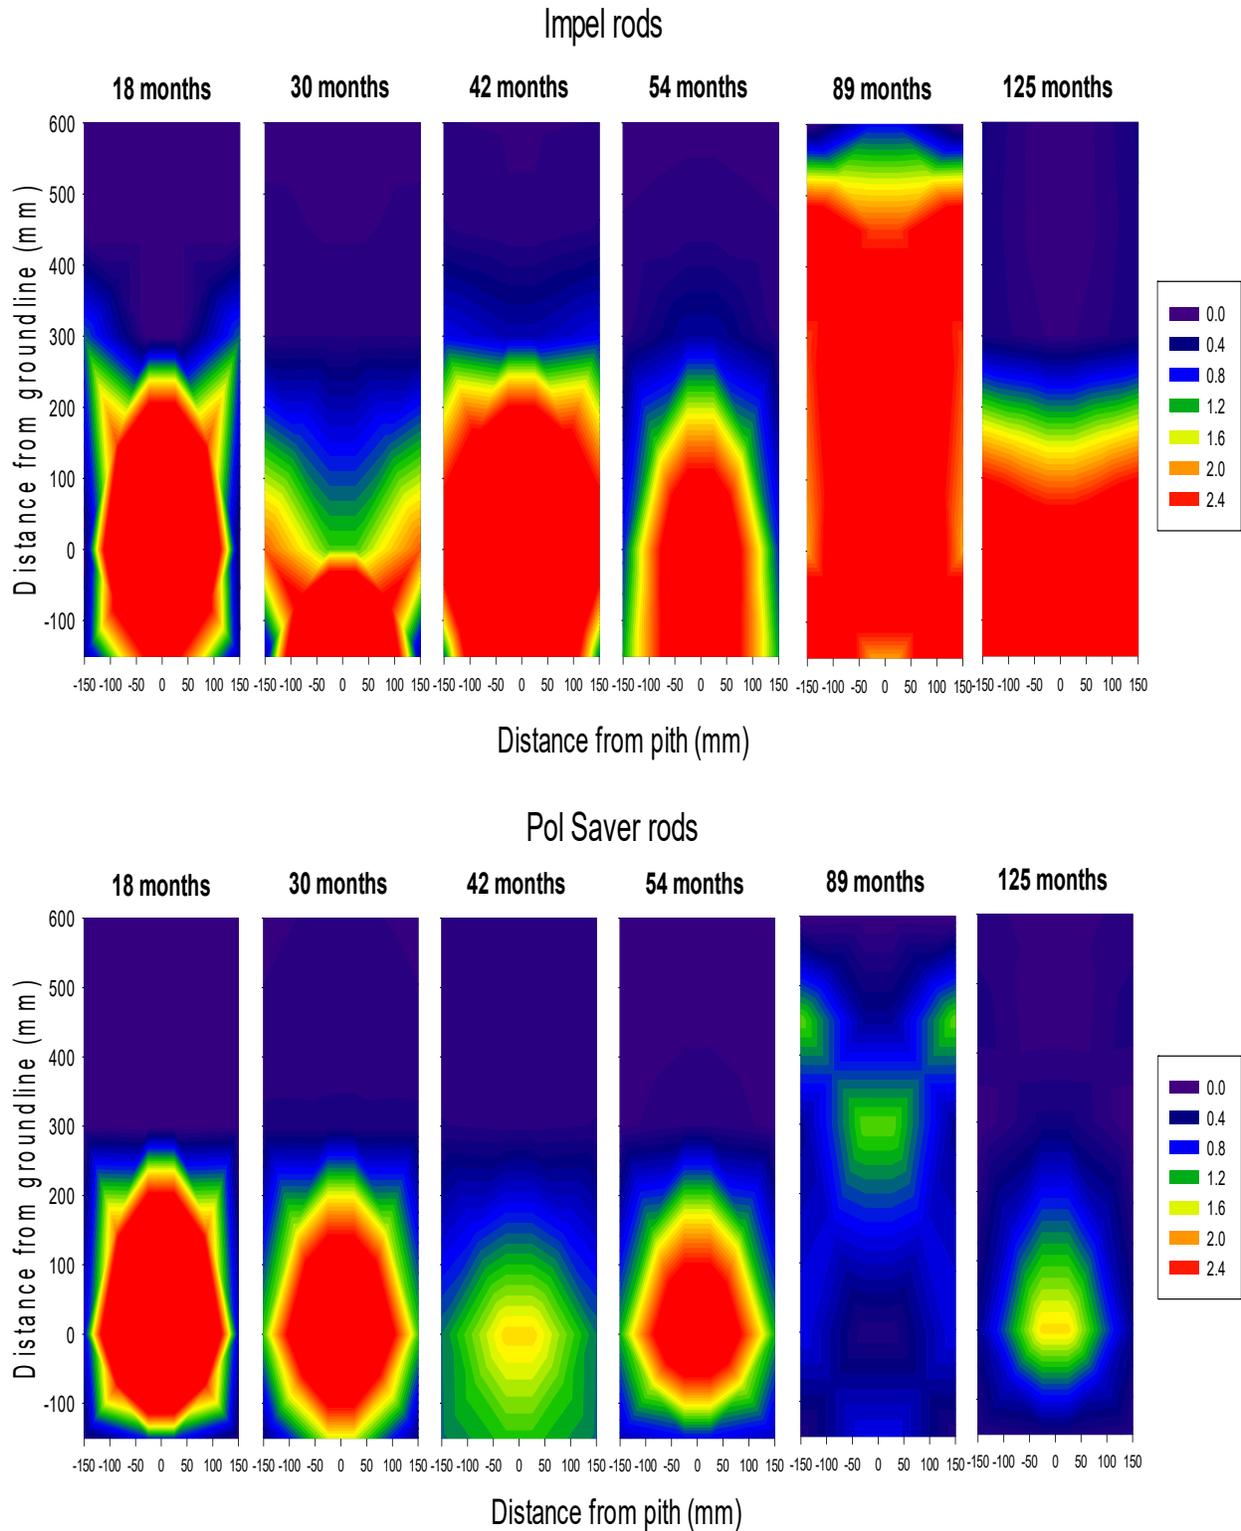
Figure I-9. Distribution of boron in Douglas-fir pole sections 18 to 125 months after treatment with Impel or PolSaver Rods. Dark blue signifies little or no chemical while increasingly light blue to green or yellow signifies boron levels above the threshold. Charts are extrapolated from individual boron analyses at assay locations described in Table I-3.

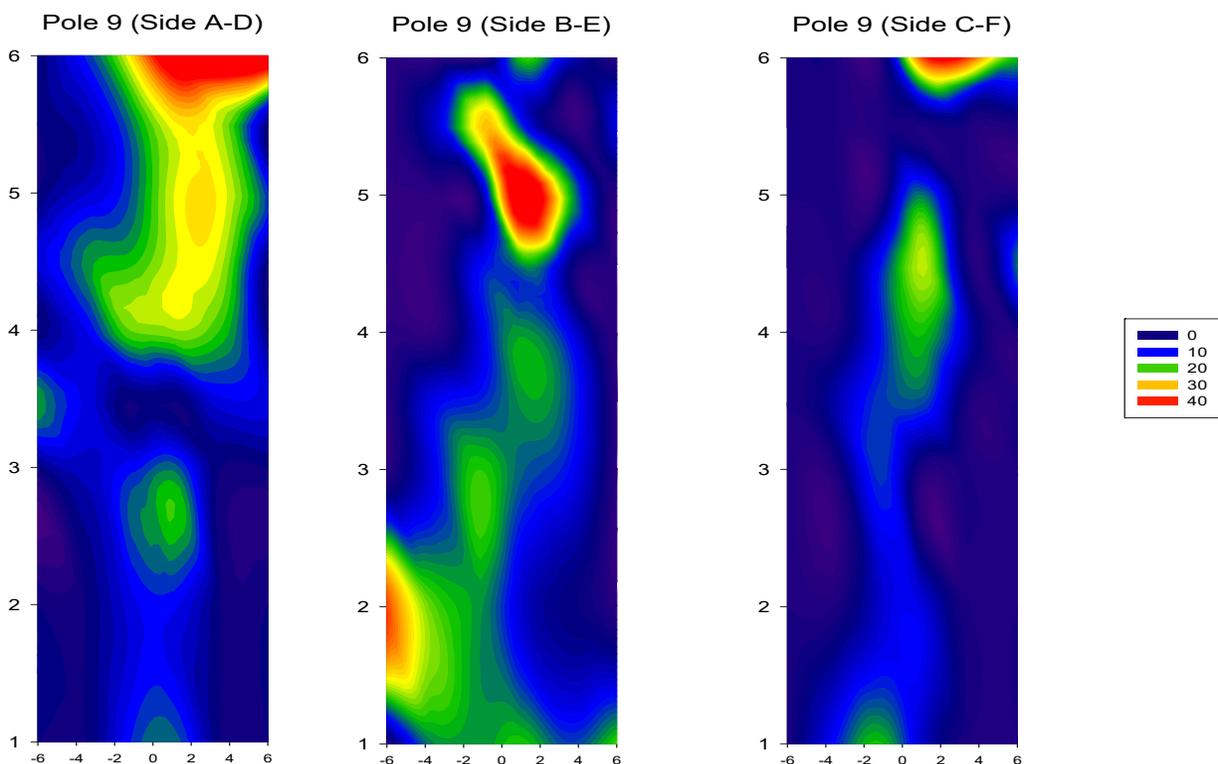
Figure I-11. Diagrams illustrating the distribution of MITC in Pole # 9 from different sides of the pole at various distances from the butt (where "1" is close to the butt and "6" is approaching groundline). Green to red colors indicate MITC levels that would be above the threshold for fungal protection.

Distance from Butt (mm)	Average MITC Content (ug/g wood)		
	Pole # 2	Pole # 8	Pole # 9
300	-	10.4	26.3
610	-	-	22.2
915	-	-	18.2
1070	-	-	21.2
1220	0.7	-	26.0
1370	1.3	1.3	25.8
1520	2.9	-	30.5
1680	-	-	30.6
1830	-	5.4	44.7

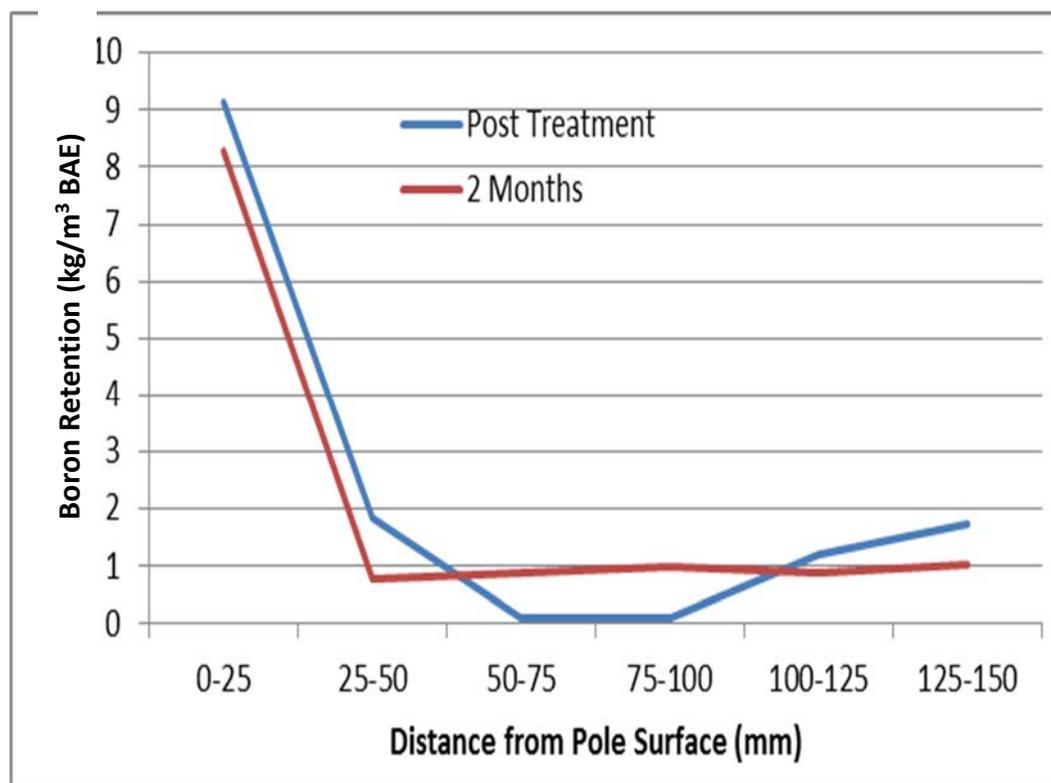
Figure II-1. Boron retentions in 25 mm increments inward from the surface in Douglas-fir poles immediately after pressure treatment with disodium octaborate tetrahydrate and again 2 months later.

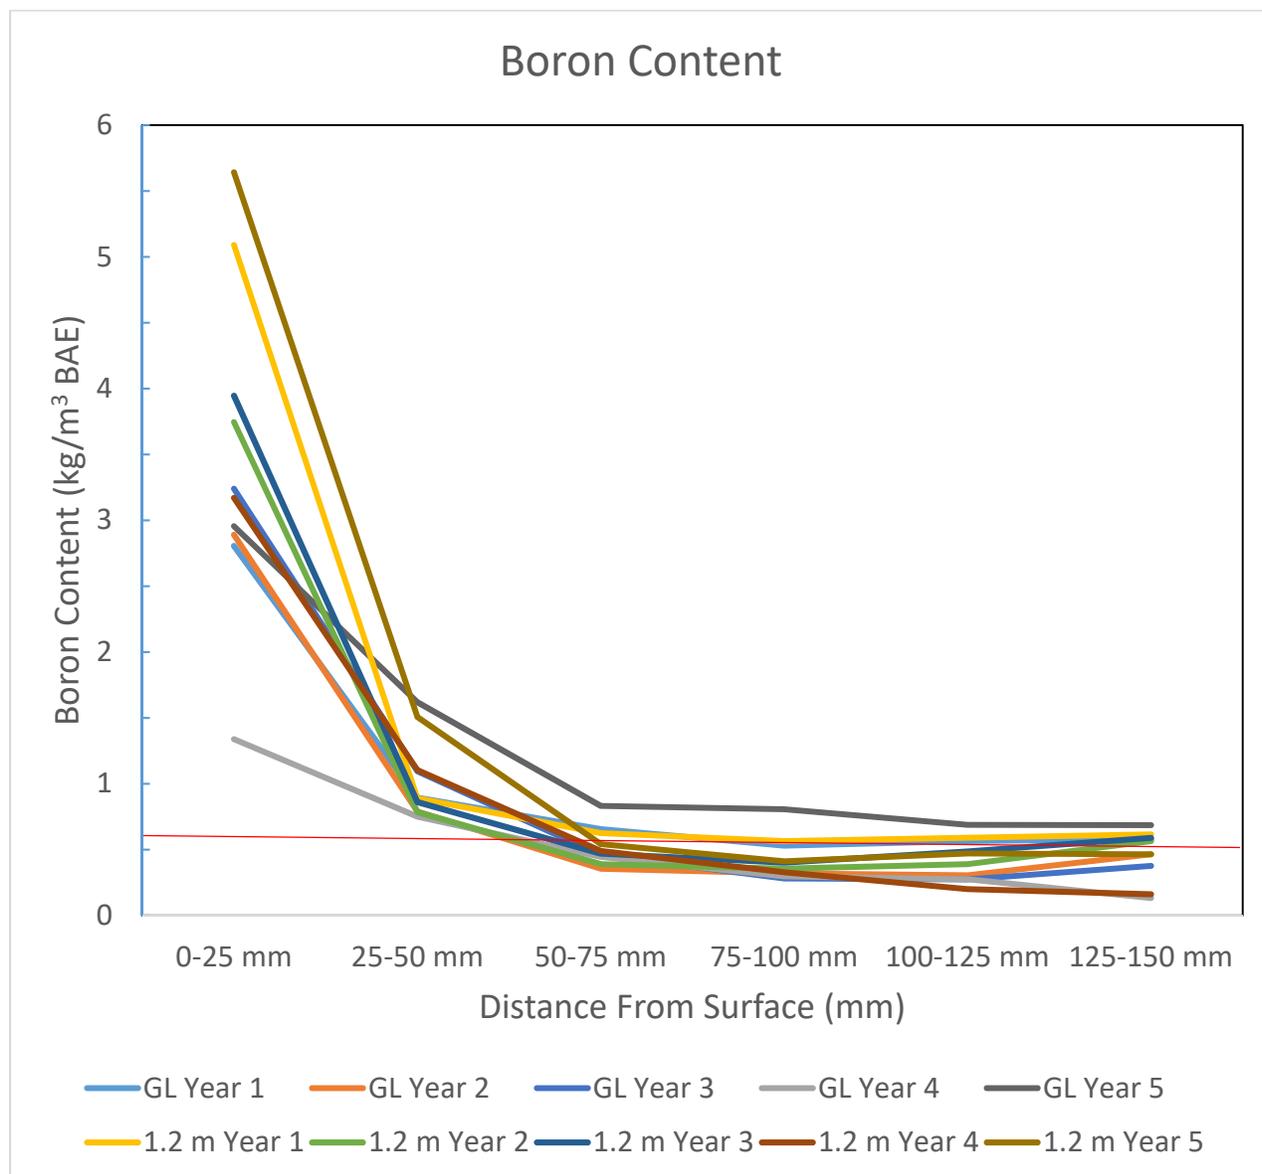
Figure II-2. Boron content at 25 mm increments from Douglas-fir pole surface 1-5 years after pre-treatment with disodium octaborate tetrahydrate followed by either kiln drying or Boulton seasoning and copper naphthenate treatment. Red line indicates 0.6 kg/m³ BAE.

Boron levels in the outer 25 mm of poles one year after treatment had declined (Figure II-2; Tables II-6, II-7). The field site receives ~1200 mm of rainfall per year and tends to be extremely wet during the winter. Previous tests revealed that interior pole moisture content at groundline tends to be above 30% most of the year, but only reaches that level above groundline near the end of winter. Elevated moisture contents are expected to help boron diffuse and distribute evenly. Declines suggest boron is moving out of poles and into surrounding soil. Boron levels in the outer 25 mm of wood 1.2 m above groundline were higher than at groundline, suggesting boron moved at the same rate out of soil contact. Boron levels were similar or slightly lower in the inner 25 to 150 mm at both heights, suggesting there had been relatively little inward movement after installation. It is important to remember that the initial boron application levels could be increased by using a stronger treatment solution. Pole sections were treated with a process typically used on lumber for the Hawaiian market and solution concentrations might have been somewhat lower than needed. Lack of substantial boron redistribution suggests that other methods may be needed to ensure boron movement beyond the surface to protect the non-treated interior once the pole is placed in service.

Boron levels in poles 2 years after installation had declined in the outer 25 mm of the poles at both groundline and 1.2 m above that level (Figure II-2; Tables II-6, II-7). Boron levels in the outer zone tended to be much higher 1.2 m above the groundline, suggesting some boron was leaching from poles in soil contact (Figure II-2). Levels further inward remained similar to those found after one year. These results suggest boron lost from the outer 25 mm zone is not moving to a substantial extent inward to help increase boron levels in those zones.

Boron levels in poles 3 years after treatment continue to remain elevated near the surface but are much lower further inward (Figure II-2). Boron levels more than 75 mm from the surface tended to vary widely and were often below threshold. The failure of boron to become more evenly distributed is perplexing, especially near groundline where moisture levels should be more than adequate for diffusion to occur.

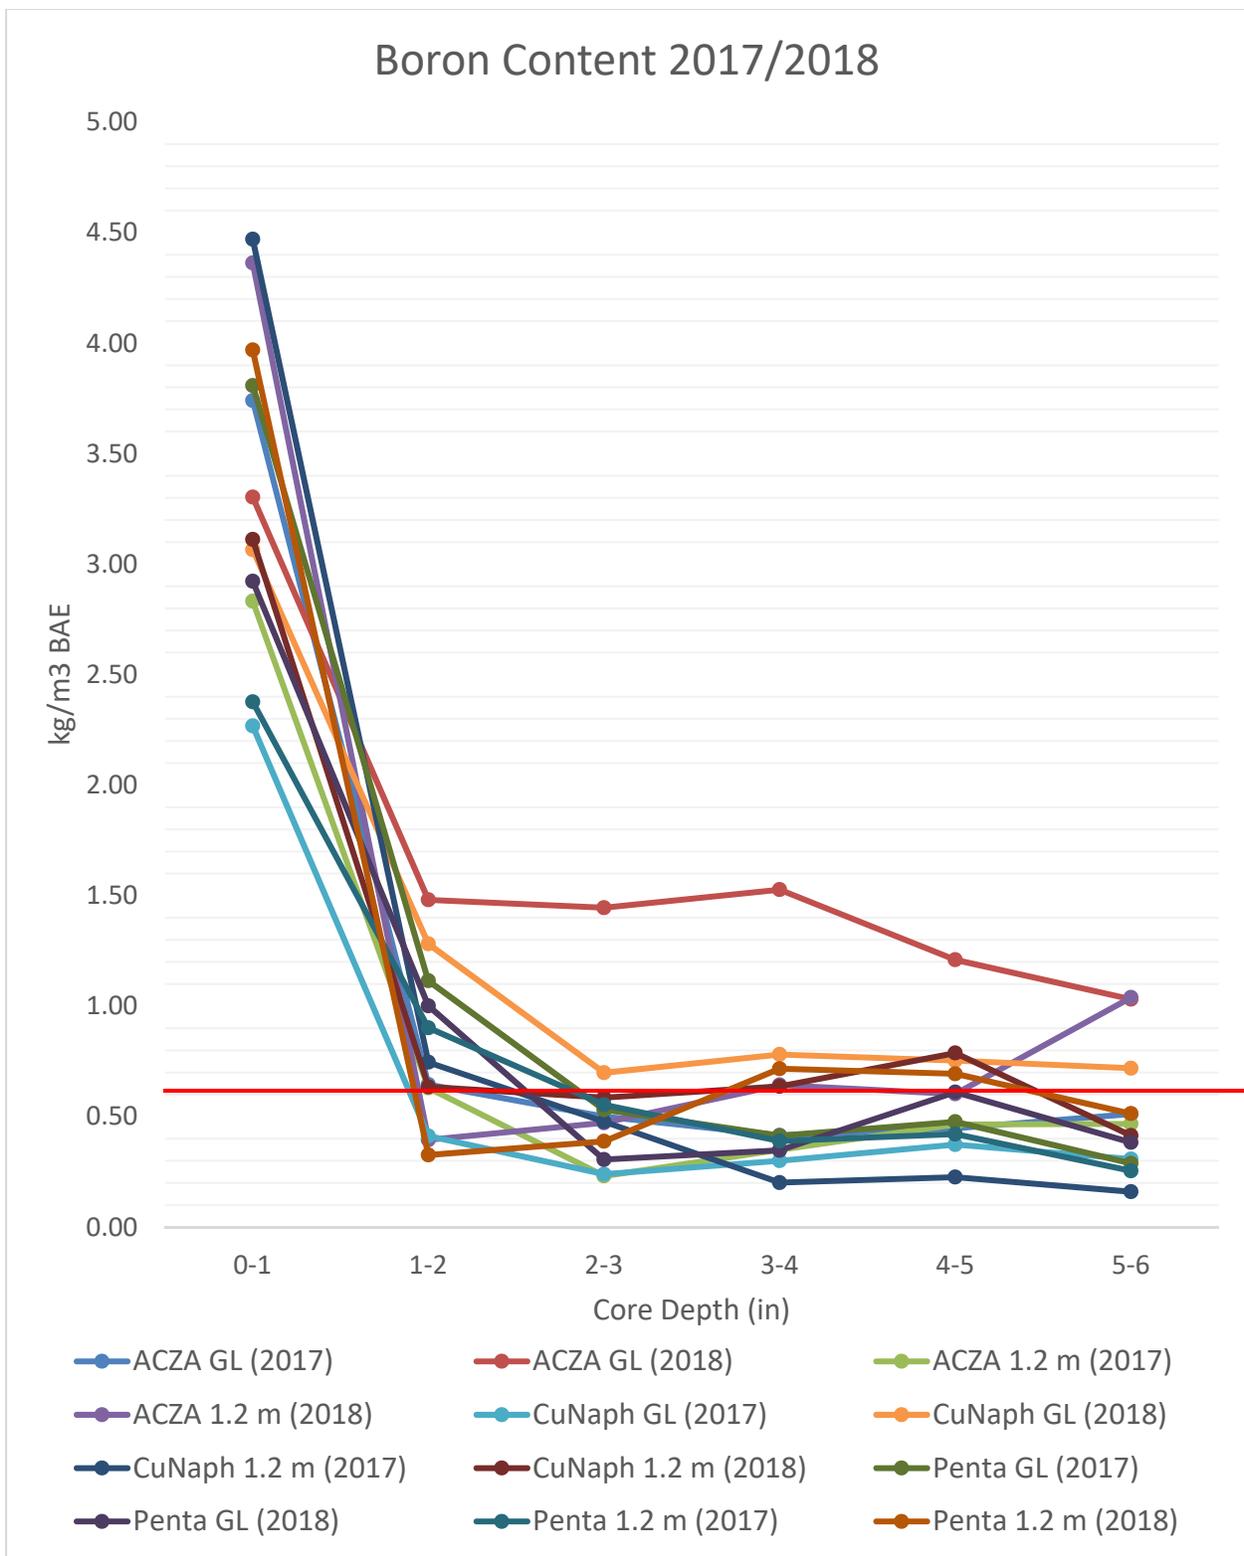
Figure II-3. Boron levels in Douglas-fir poles subjected to either a boron pre-treatment followed by over-treatment with copper naphthenate or pentachlorophenol, or an ACZA/boron pressure treatment. Red line indicates 0.6 kg/m³ BAE.

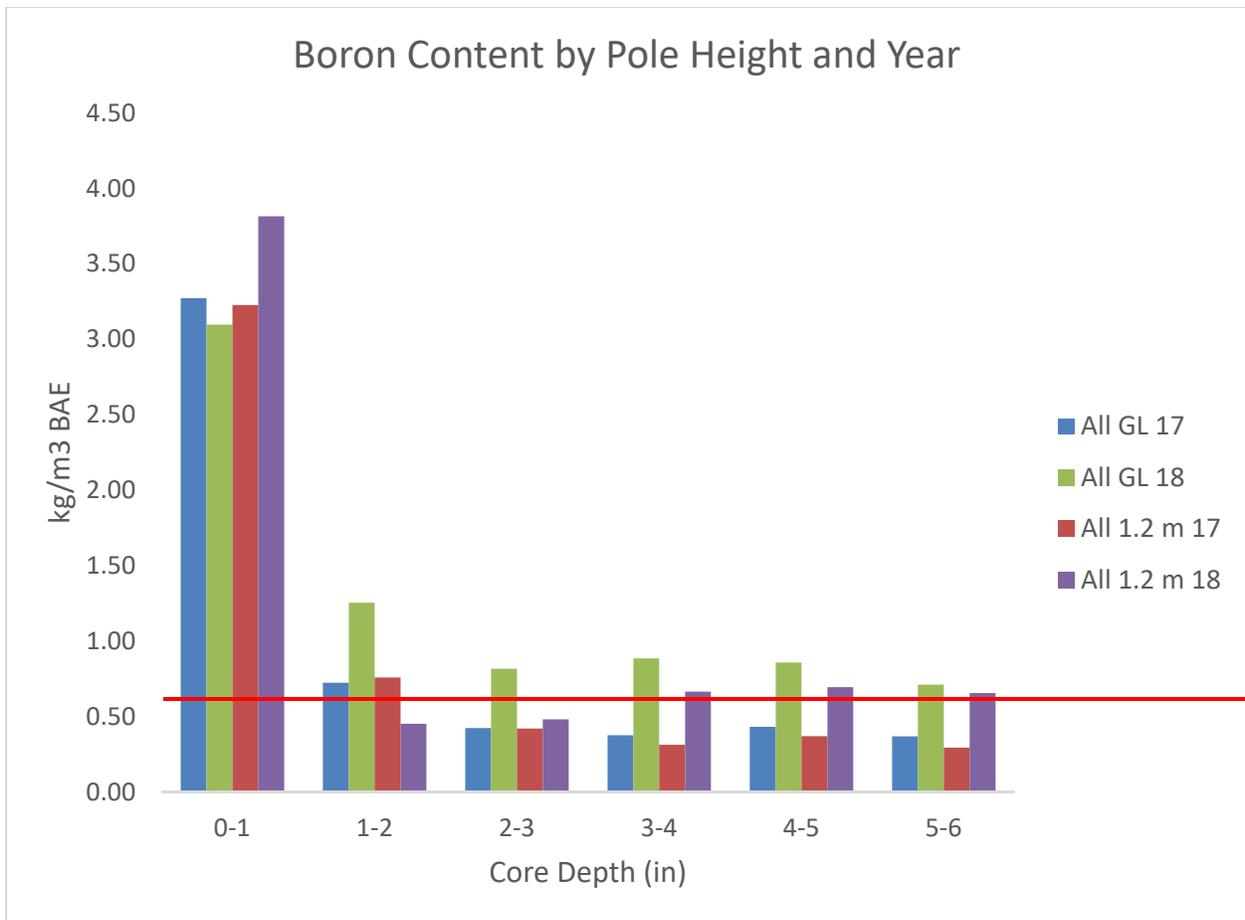
Figure II-4. Combined boron levels in Douglas-fir poles subjected to a boron pre-treatment followed by over-treatment with copper naphthenate or pentachlorophenol, or an ACZA/boron pressure treatment. Red line indicates 0.6 kg/m³ BAE.

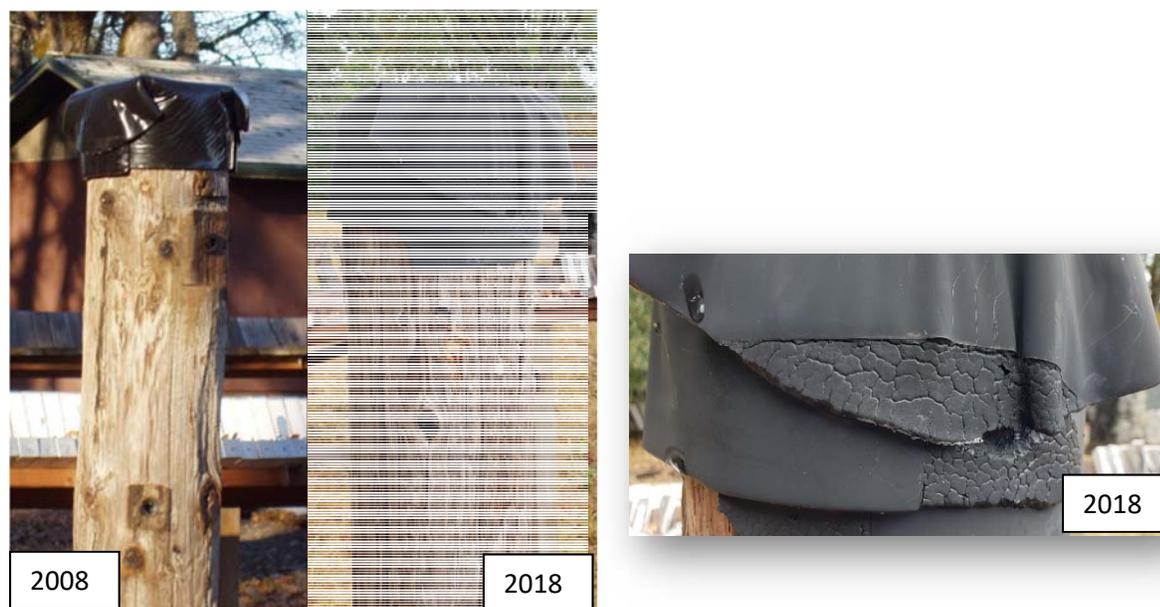
Figure III-1. Example of the condition of water-shedding caps at the start of exposure and after 126 months of exposure in Corvallis, OR.

One concern about the caps is their expected service life. The caps are exposed to severe ultraviolet light radiation and many plastics are susceptible to UV damage. However, the caps remained sound and free of damage that might allow moisture to intrude into the wood (Figure III-1). The results clearly show the benefits of capping in terms of reducing internal moisture content. Ultimately, reducing the time when conditions are suitable for fungal growth should translate into improved performance.
