Oregon State University Utility Pole Research Cooperative (UPRC)

**Department of Wood Science & Engineering
38th Annual Report
2018**

**By:
Jed Cappellazzi and Matt Konkler**

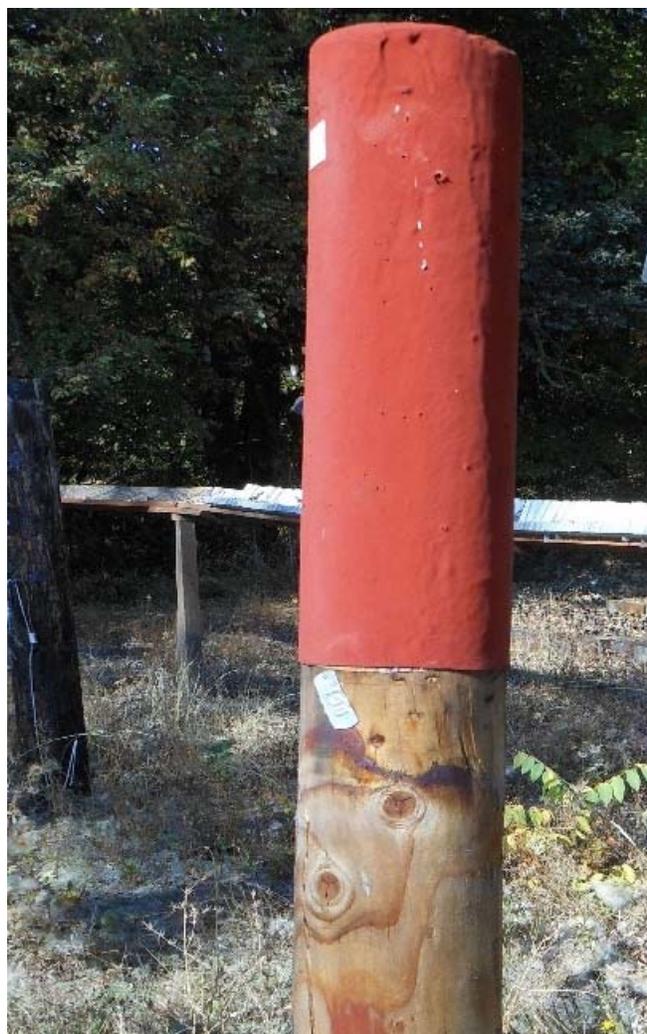
Figure III-2. Example of a polyurea capped pole top.

We wondered if these materials would also be effective for protecting the tops of newly installed utility poles. To investigate this possibility, six penta-treated Douglas-fir pole sections (3 m long) were coated with polyurea from the tip to approximately 0.9 m below that zone (Figure III-2). The poles were set to a depth of 0.6 m at a test site on the OSU campus. Increment cores were removed from the non-coated section of the pole and divided into inner and outer 25 mm sections as described above. Each core section was weighed immediately after removal from the pole, oven-dried, and re-weighed. The difference was used to determine MC. The sampling hole was covered with a patch of seal-fast tape (Mule-Hide Products, Beloit, WI). Moisture contents at the time of installation ranged from 16.0 to 31.8%. The averages for the inner and outer zones were 23.8% and 19.0%, respectively (Table III-2). The poles, installed in the spring of 2011, were sampled after 4, 12, 16, 24, 38, 61, and 74 months of exposure to assess the effect of the polyurea coating on internal moisture. Increment cores were removed in the same manner as previously described for the first capping test and MC was determined for each pole by weighing, then oven drying and weighing the cores again. Non-coated, non-capped poles from the previously-installed moisture shedding pole cap study served as controls. The condition of the surface coating was also visually monitored for evidence of adhesion with the wood as well as the development of surface degradation.

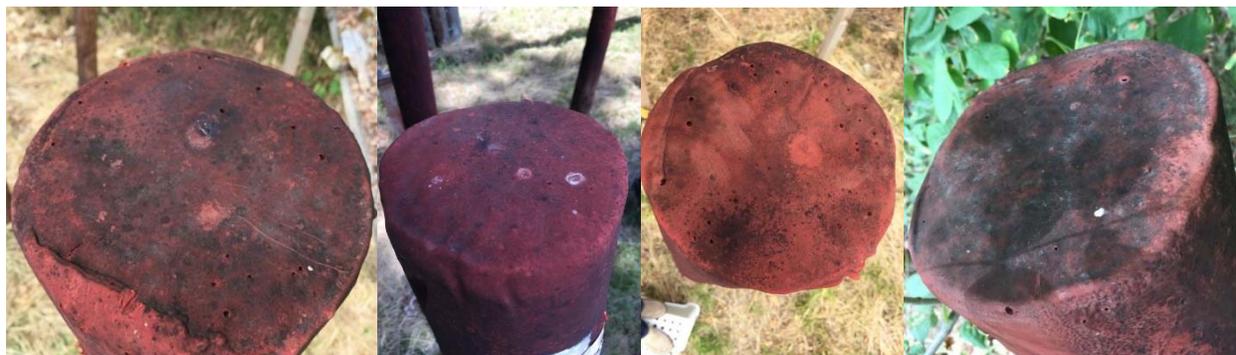
Figure III-3. Condition of polyurea coatings on the tops of Douglas-fir pole sections after 61 months of exposure in Corvallis, OR.

The caps remain sound and free of damage ~6 years after installation (Figure III-3). Moisture contents of non-coated poles varied with season and were consistently above 30% during the winter months. Moisture contents were often above 30% during the dryer summer months suggesting that the wood in these poles was wet enough for decay to progress continually throughout the year.

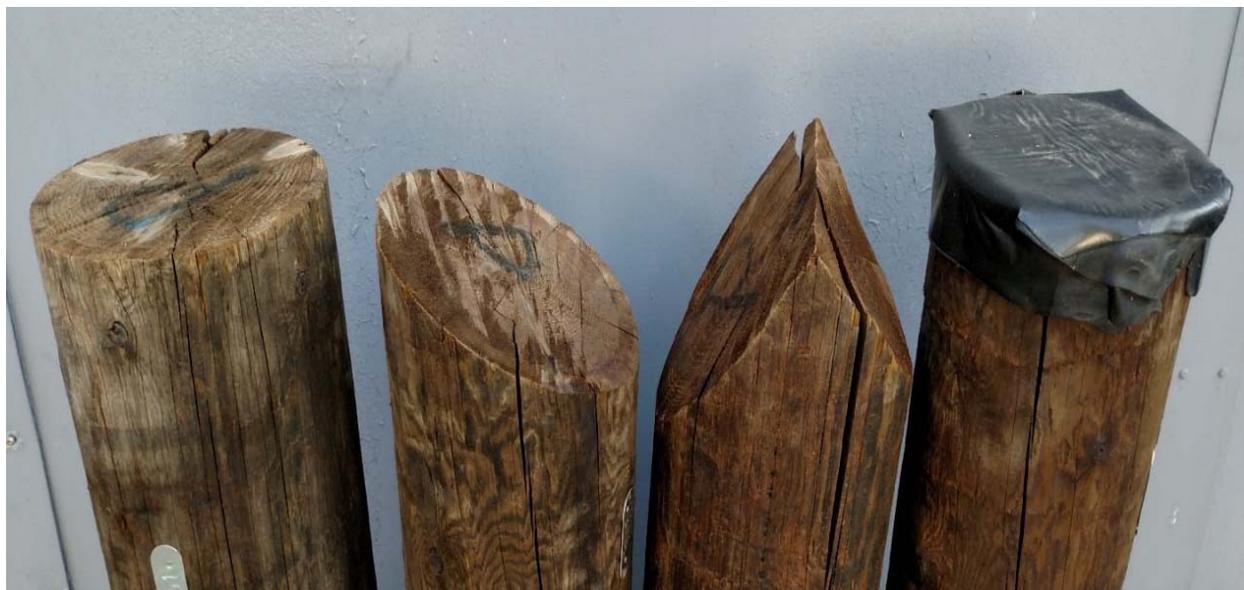
Figure III-4. Examples of the different pole top roofing patterns assessed for their ability to resist moisture ingress.

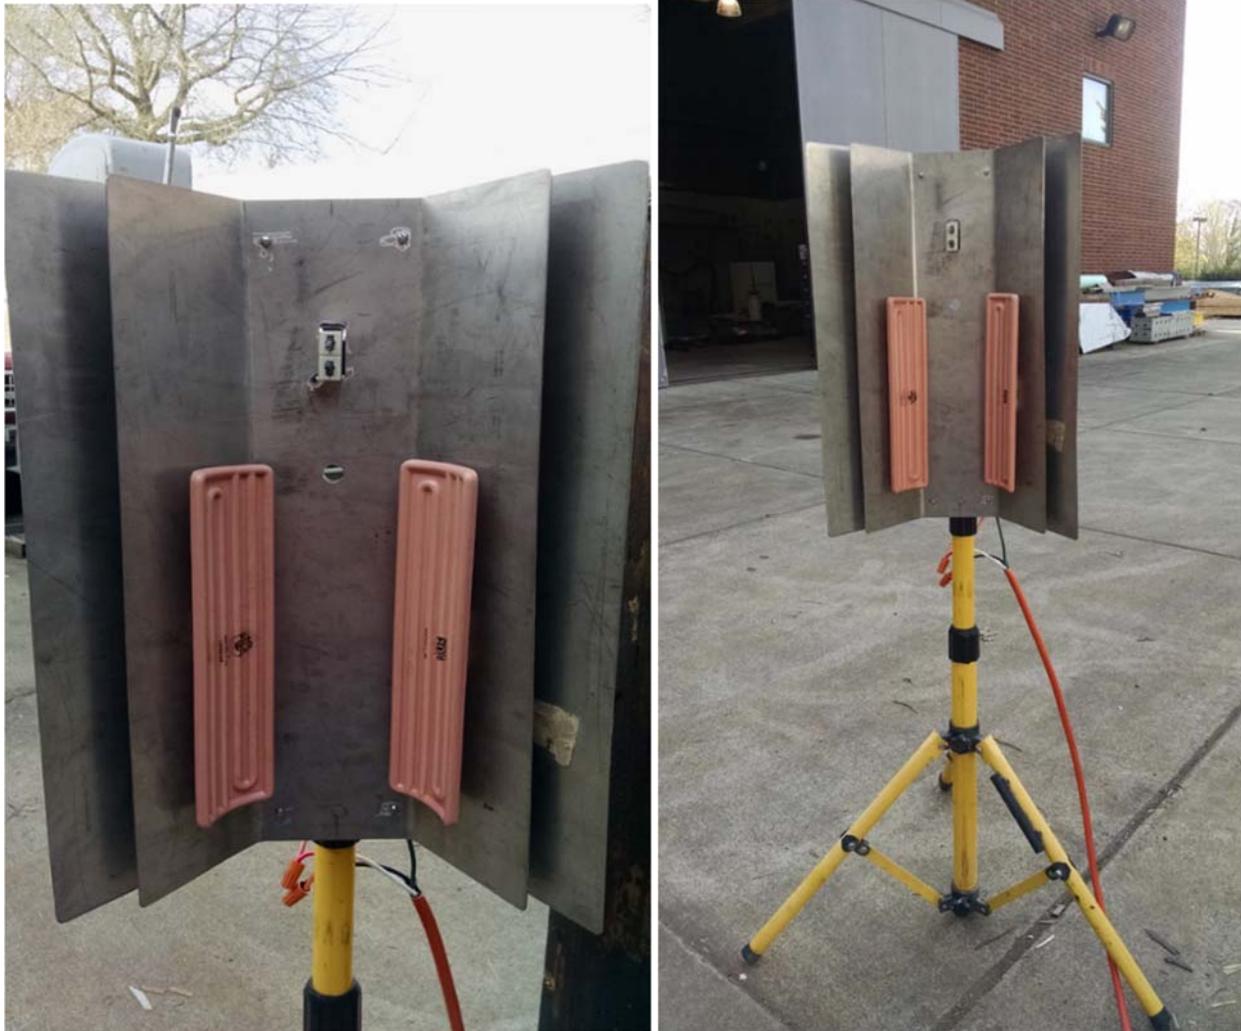
Figure III-5. Example of the small-scale fire test apparatus showing the heating shield on a tripod and a close up of the heating elements.

We have previously reported on our new method developed by the Utility Pole Research Cooperative to assess the performance of fire-retardant systems. The test method is relatively simple and inexpensive, but reproducible. The device uses a stainless-steel shield to contain the heat as close to the pole as desired (Figure III-5). Two infrared heating elements are placed along the stainless-steel walls. A thermocouple is placed into the pole from the poles backside (non-heated side) to within 6 mm of the pole surface on the heat-exposed face. This thermocouple is connected to a data-logger to record temperature during exposure. In addition, an infrared scanner is used to monitor air temperature between the heating elements and wood. The system allows the pole surface to be heated incrementally with the ability to determine maximum temperatures as well as surface temperatures over the exposure period. In preliminary testing, poles were allowed to burn for 20 minutes after ignition (they could also be run to failure). In order to reduce the potential for smoke complaints, burn time was shortened to 10 minutes in subsequent tests. The degree of protection afforded by a treatment can be assessed by determining depth of char and the area burned. In addition, thermal data can provide clues as to how a given system performed, although characteristics such as time to ignition may not be useful since some treatments may actually begin to react much earlier in order to form a protective char layer.

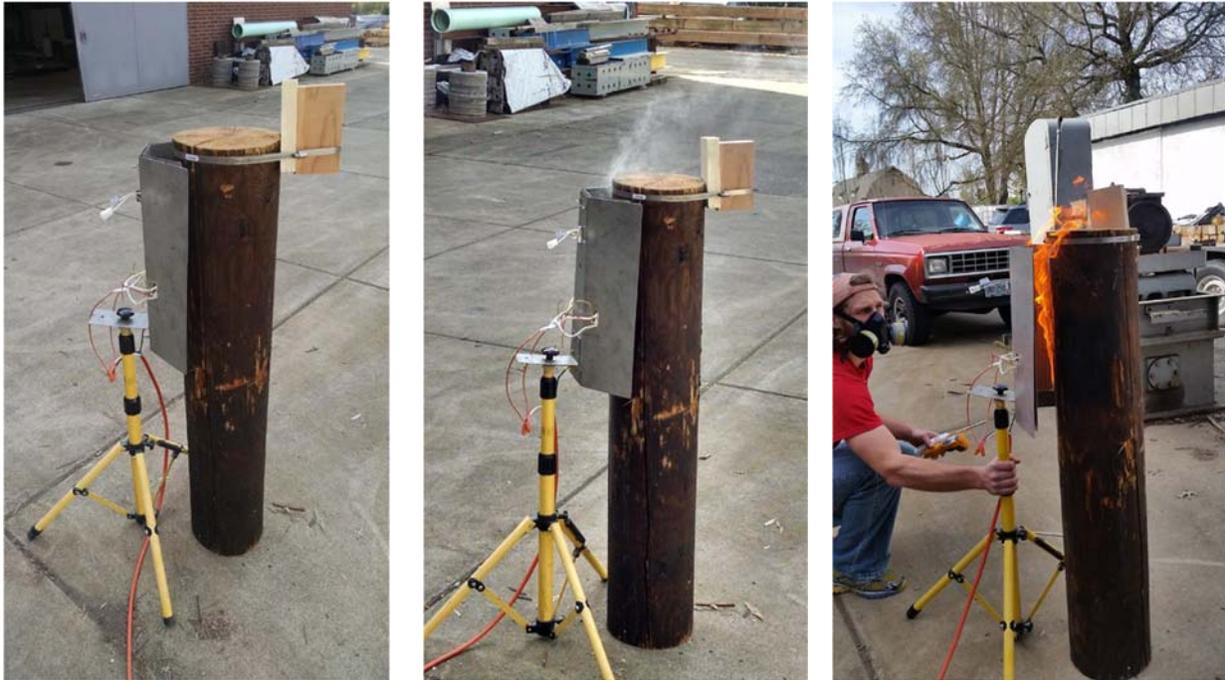
Figure III-6. Example of the fire test apparatus being applied to a penta-treated Douglas-fir pole showing initial heating, the beginning of combustion with smoke and finally, the pole on fire.

The device was evaluated on a limited number of poles without supplemental fire protection (Figure III-6). Penta-treated Douglas-fir pole stubs (~150 mm diameter by 1 m long) were conditioned to approximately 6% MC before being tested. The device was placed 150 mm away from the pole and the test was initiated. Infrared readings were taken every 10 seconds until ignition, then the flames were allowed to continue for 20 minutes before being extinguished. The design permits variation of test conditions including heat intensity, proximity to the heating source, and time of heat exposure. Untreated poles rapidly ignited and continued to burn until they were extinguished. The test apparatus was simple and very inexpensive to construct. The total cost for the assembly was less than \$200 and provided a system that was easy to move, reproducible, and simple to operate.

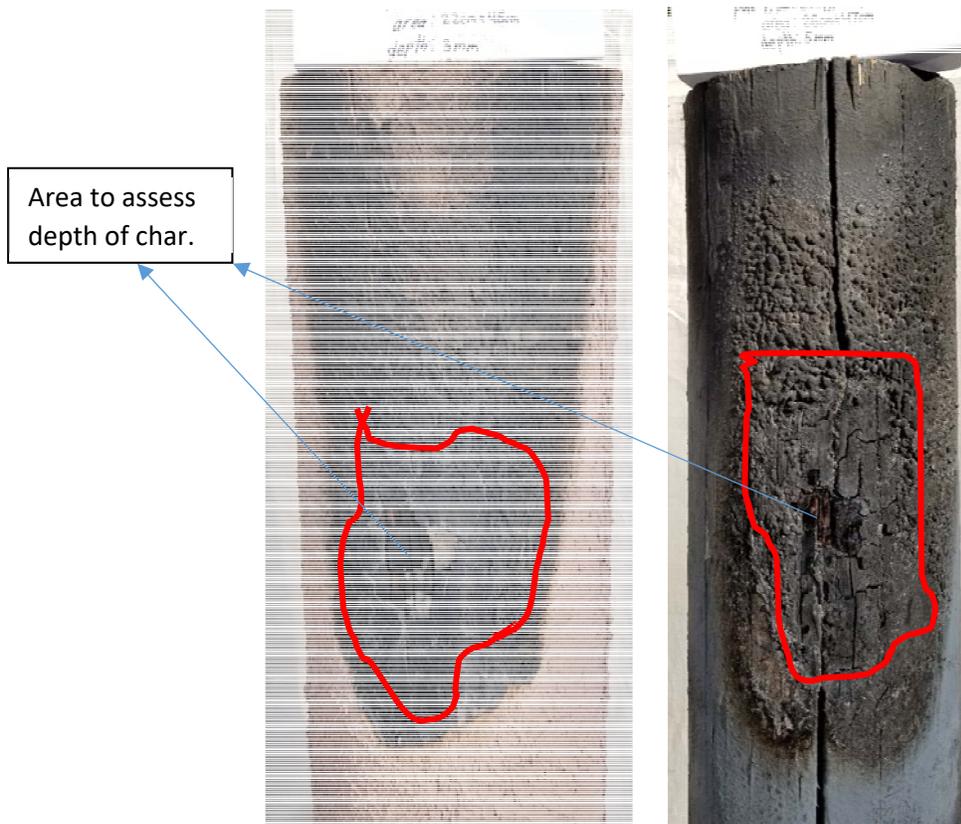
Figure III-7. Example of burned poles showing char, rough char area, and depth of char visualized by scraping surface char away.

tests, the area charred by the fire was estimated, then the depth of char was measured by scraping away the charred wood until sound, non-charred wood was visible (Figure III-7). The depth of the wood removed was then measured to the nearest mm. One other approach would be to use loss in circumference; however, this measure is less useful because the current test apparatus only applies heat to one face of the pole and poles are not allowed to burn to completion. Thus, any loss in cross section is limited by the surface area exposed. These tests are continuing and only one pole treated with each system has been evaluated.

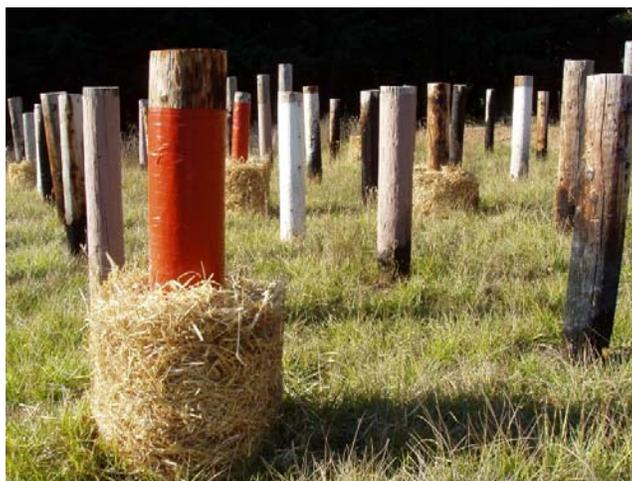
Figure III-8. Example of a pole section with straw fuel in a wire cage prior to ignition.

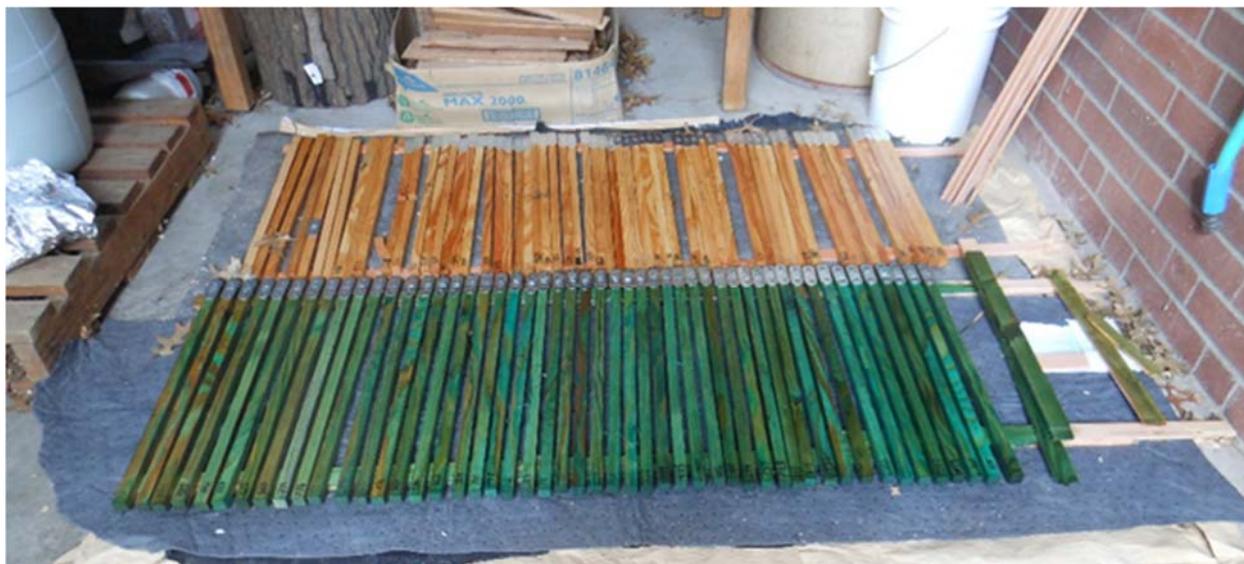
Figure III-9. Stakes drying under cover after treatment with copper naphthenate (bottom) or penta (top).

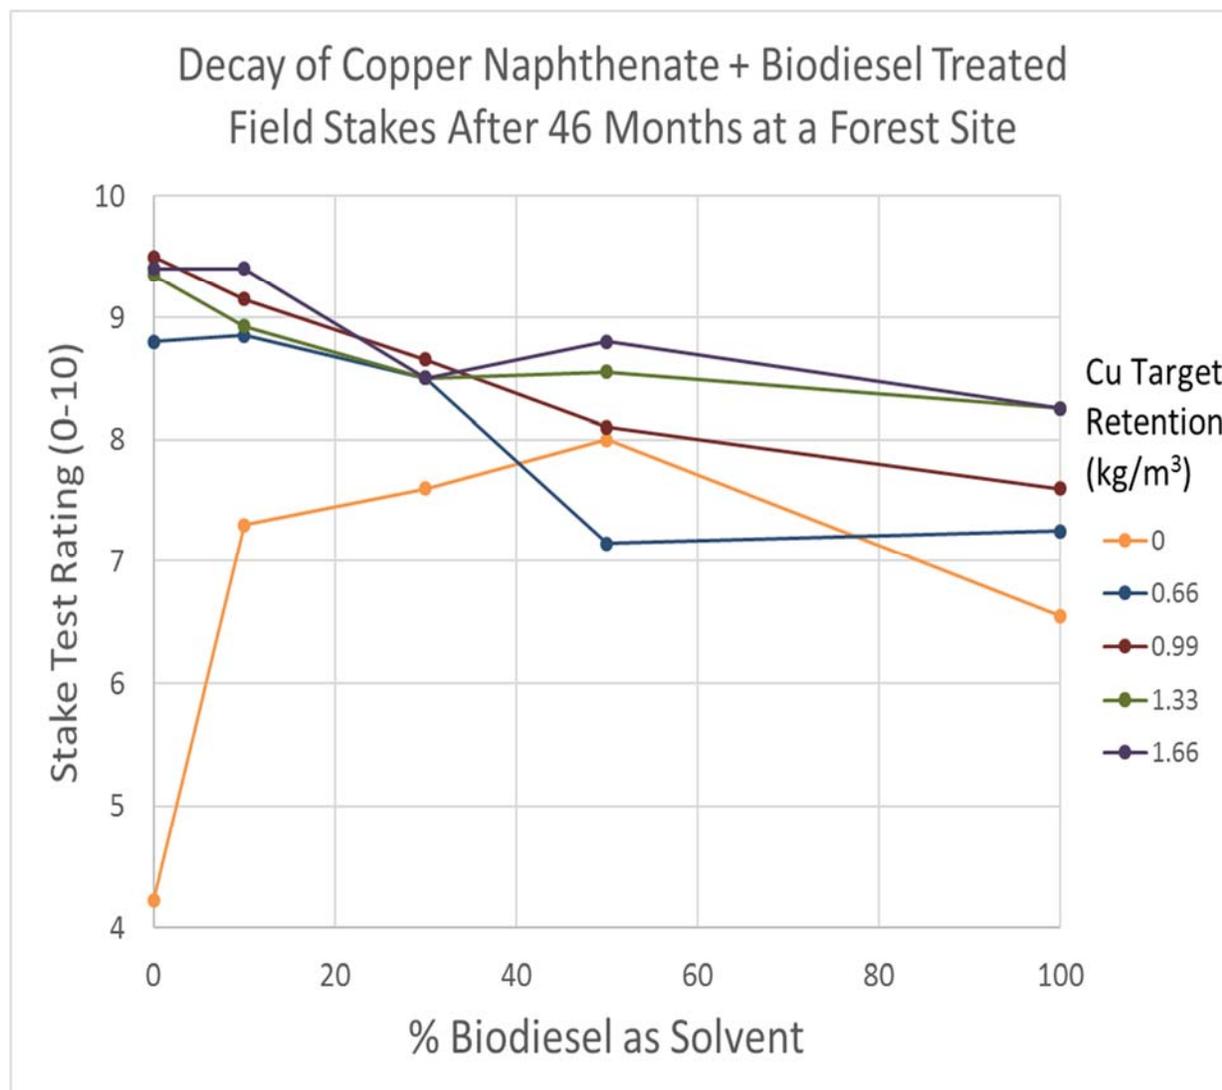
Figure III-10. Average ratings of Douglas-fir sapwood stakes at the forest site treated with copper naphthenate in mixtures of petroleum and bio-based diesel after 46 months of exposure in soil showing the relationship between increased biodiesel content and increased decay.

representative of field performance (AR 2015). Stakes treated with copper naphthenate in petroleum diesel/biodiesel blends exhibited increased decay with increasing biodiesel levels, with the heaviest decay in stakes treated using 100% biodiesel (Figures III-10, III-11, and III-12). It is important to note that stakes treated with petroleum diesel are performing well. The status of our biodiesel field trails in 2017 is shown in Figure III-13, while selected stakes and the trial site are shown in figures III-14 and III-15.

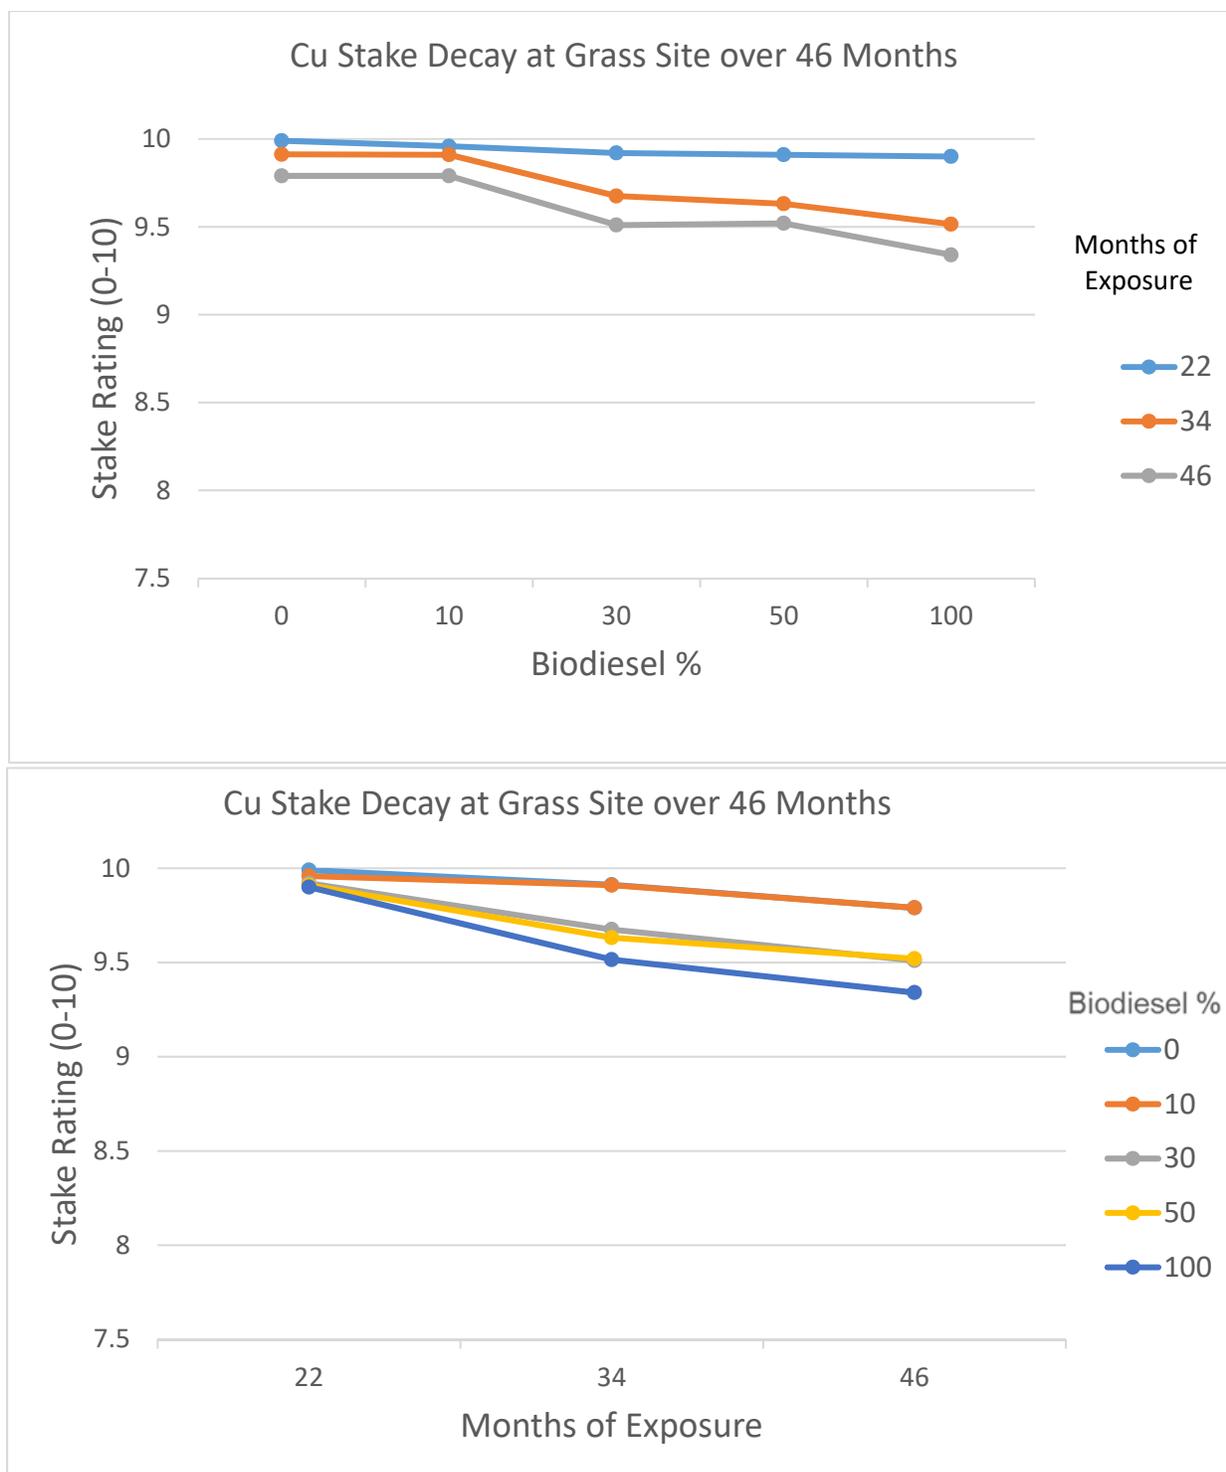
Figure III-11. Average ratings of Douglas-fir sapwood stakes at the grass site treated with copper naphthenate in mixtures of petroleum and bio-based diesel over 46 months of exposure in soil showing the relationship between increased biodiesel content and increased decay. These data combined all of the Cu retentions for each individual biodiesel level.

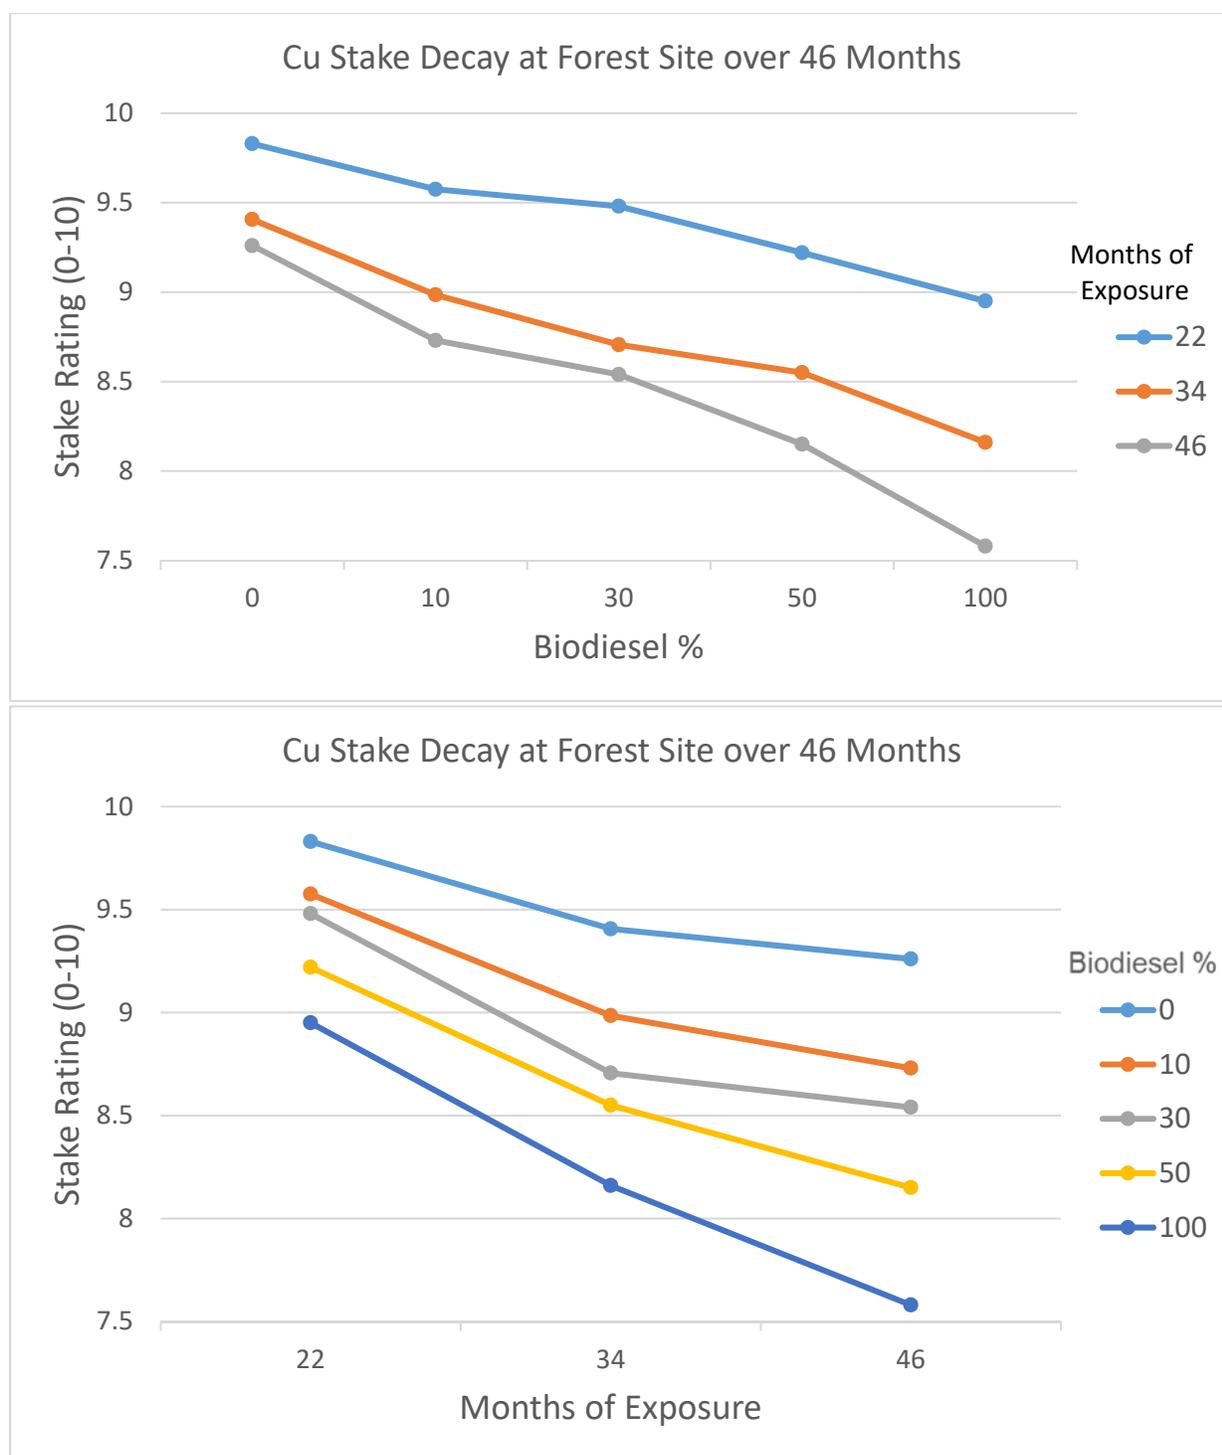
Figure III-12. Average ratings of Douglas-fir sapwood stakes at the forest site treated with copper naphthenate in mixtures of petroleum and bio-based diesel over 46 months of exposure in soil showing the relationship between increased biodiesel content and increased decay. These data combined all of the Cu retentions for each individual biodiesel level.

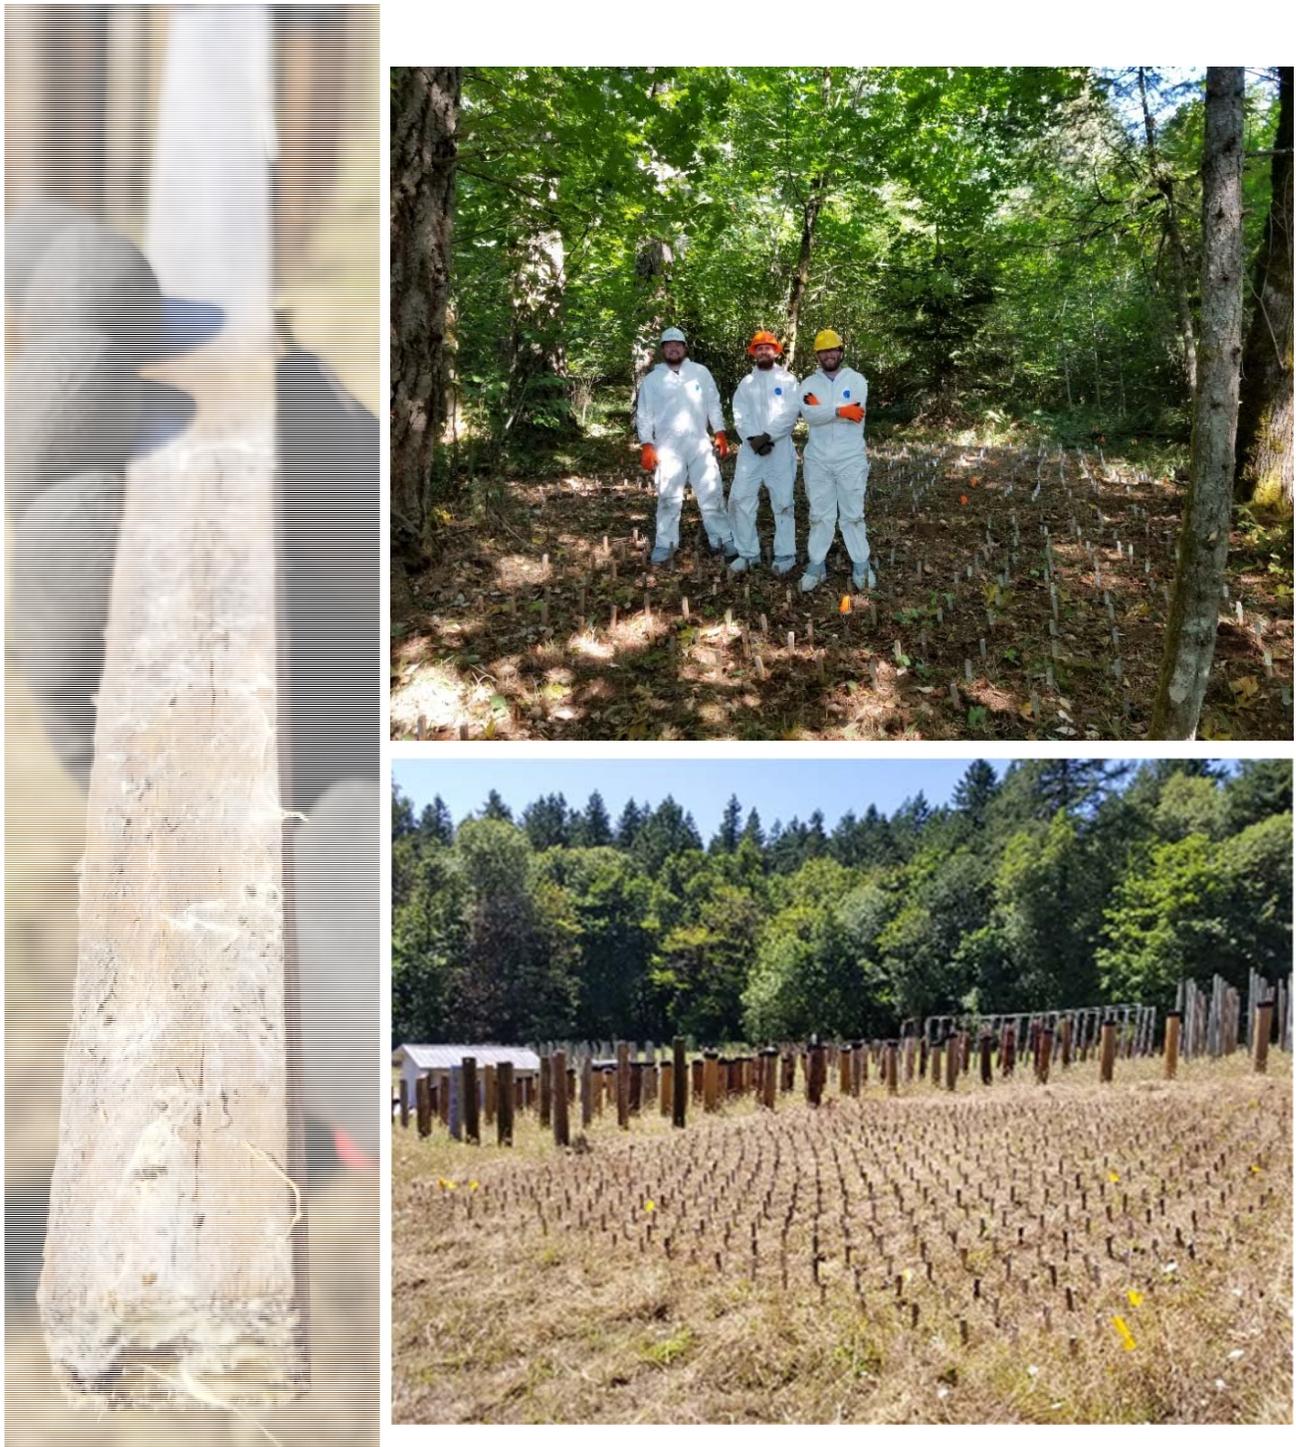
Figure III-13. Composite photo showing a control stake at the field site, the forest site, and the field site in early September 2017.

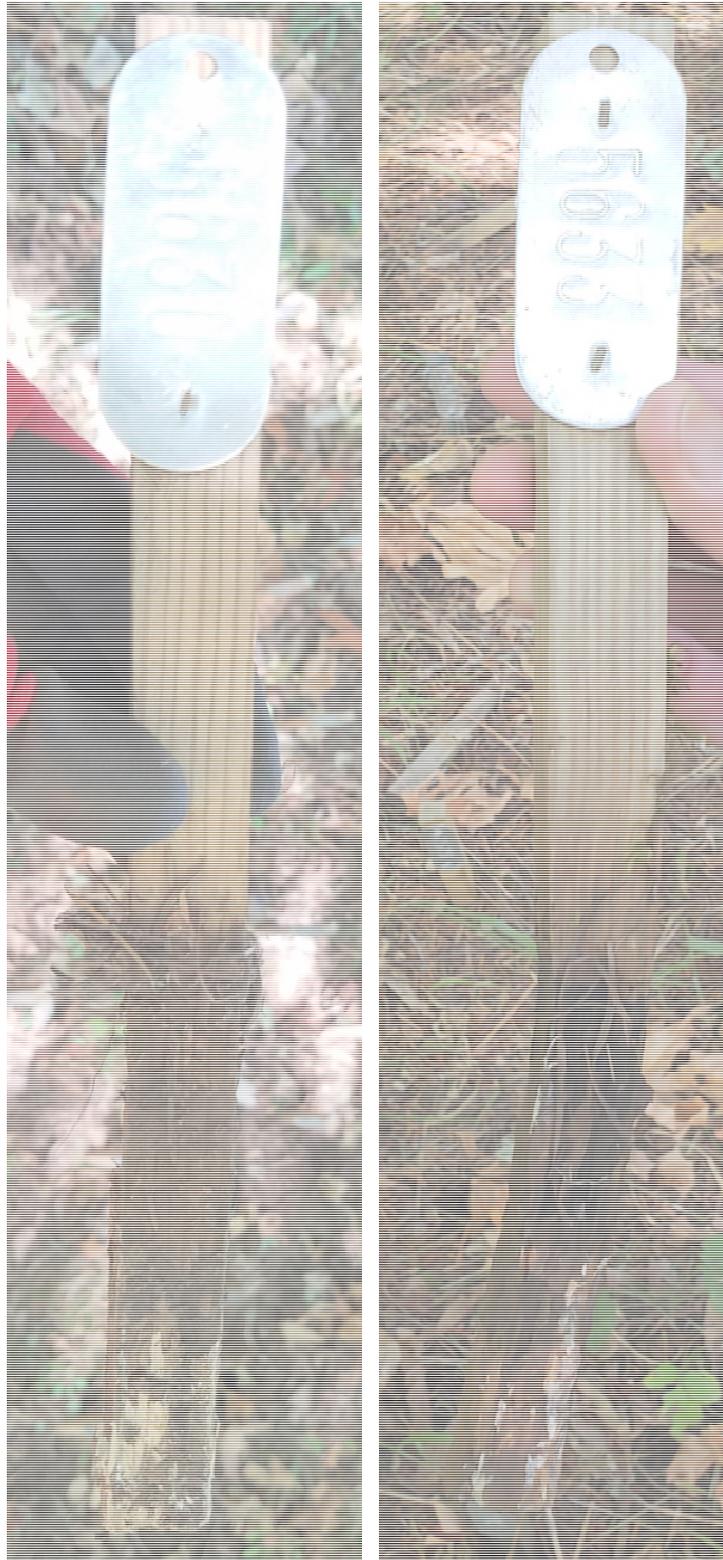
Figure III-14. Photos showing the same control stake from the wood site in 2016 (left) and 2018 (right).

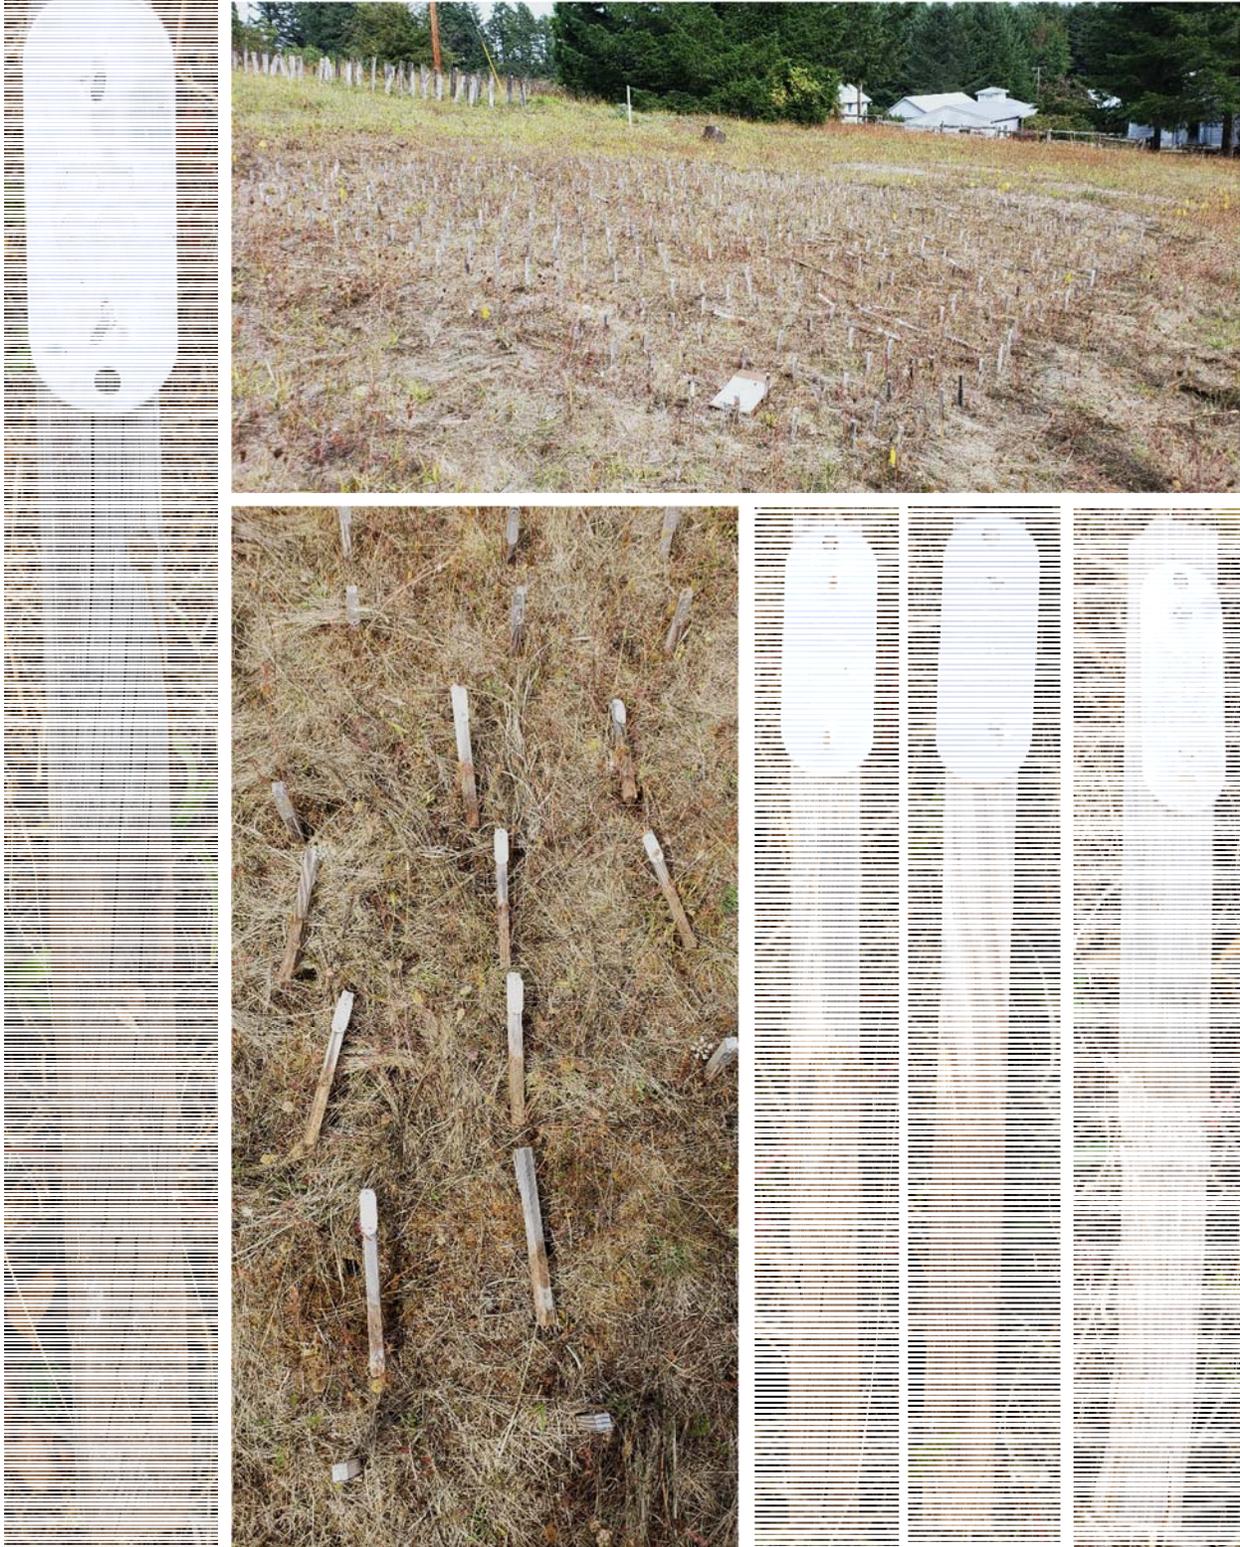
Figure III-15. Photos from the field site in 2018 showing various levels of decay.

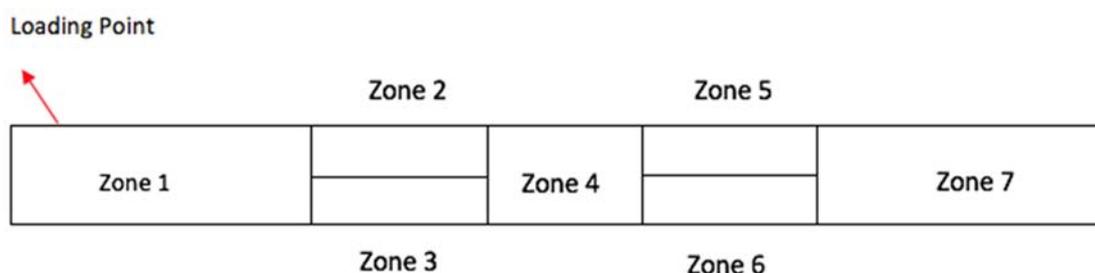
Figure III-16. Zone delimitation for crossarms used to separate defects.

The resulting data were used to calculate Modulus of Rupture (MOR) and Modulus of Elasticity (MOE) and were compared with arm characteristics that included knot diameter and location. Data analysis focused on comparisons of knot area in different zones with MOR. The zone of failure was determined by post-test visual assessment and the total defect area in that zone was compared to the total area observed in failure zones of the other arms. Knot areas of tension zones were compared in a similar

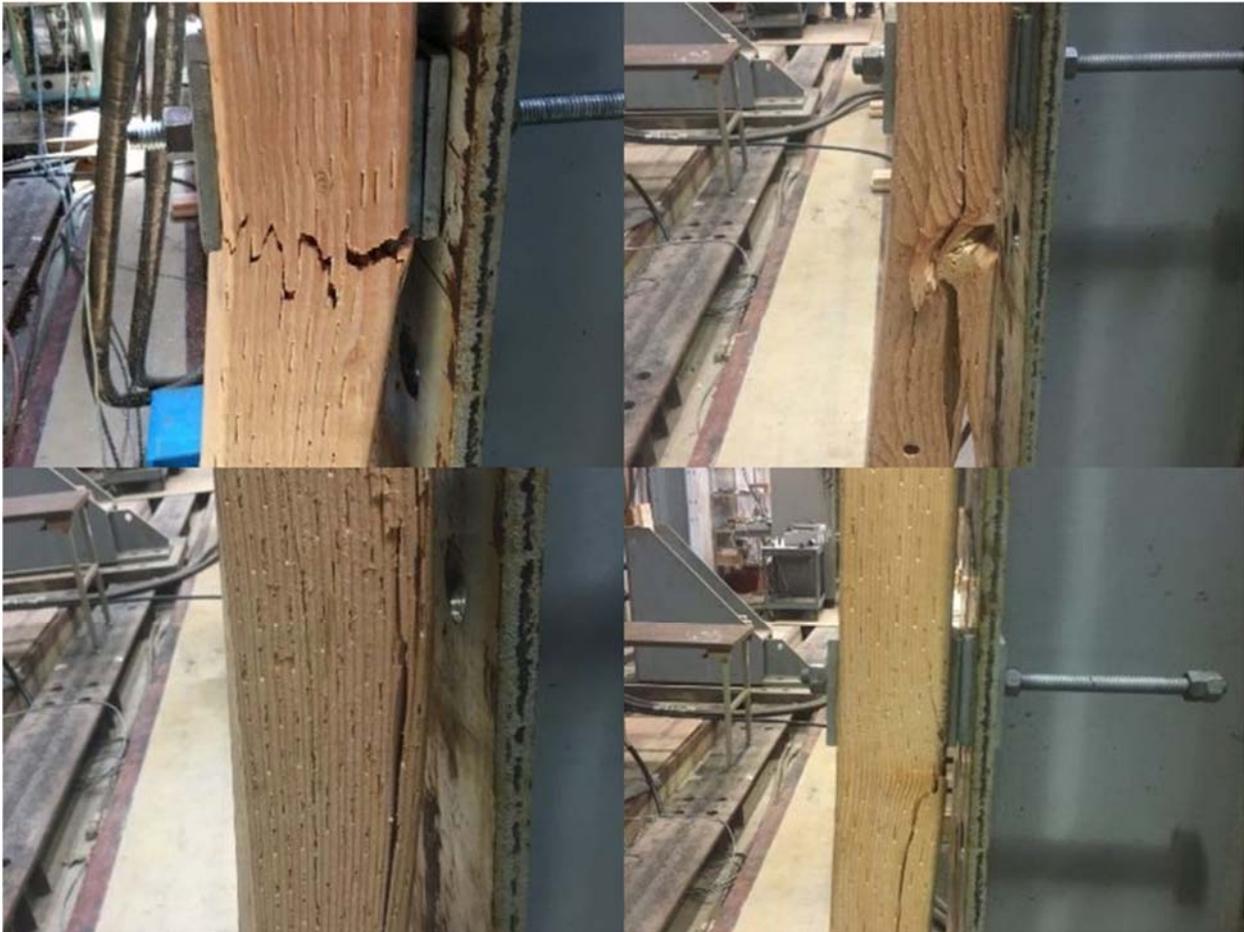
Figure III-17. Examples of various failures of Douglas-fir crossarms tested to failure in bending.

The arms failed in a variety of modes, but the majority failed in tension along a defect. The ANSI 05.3 standard specifies a minimum MOR of 7800 psi for Douglas-fir arms. MOR values were above this minimum for 49 of the 50 acceptable arms and the value for the one arm below this minimum was nearly 7000 psi (Figure III-17). Results indicated 98% of the currently acceptable arms met the minimum value and the majority of arms had MOR values between 10000 and 13000 psi. One positive attribute of wood variability is the fact that we establish minimum values well below those for a majority of a population. This means that systems have a substantial amount of excess capacity that helps them perform well under extreme loading conditions.

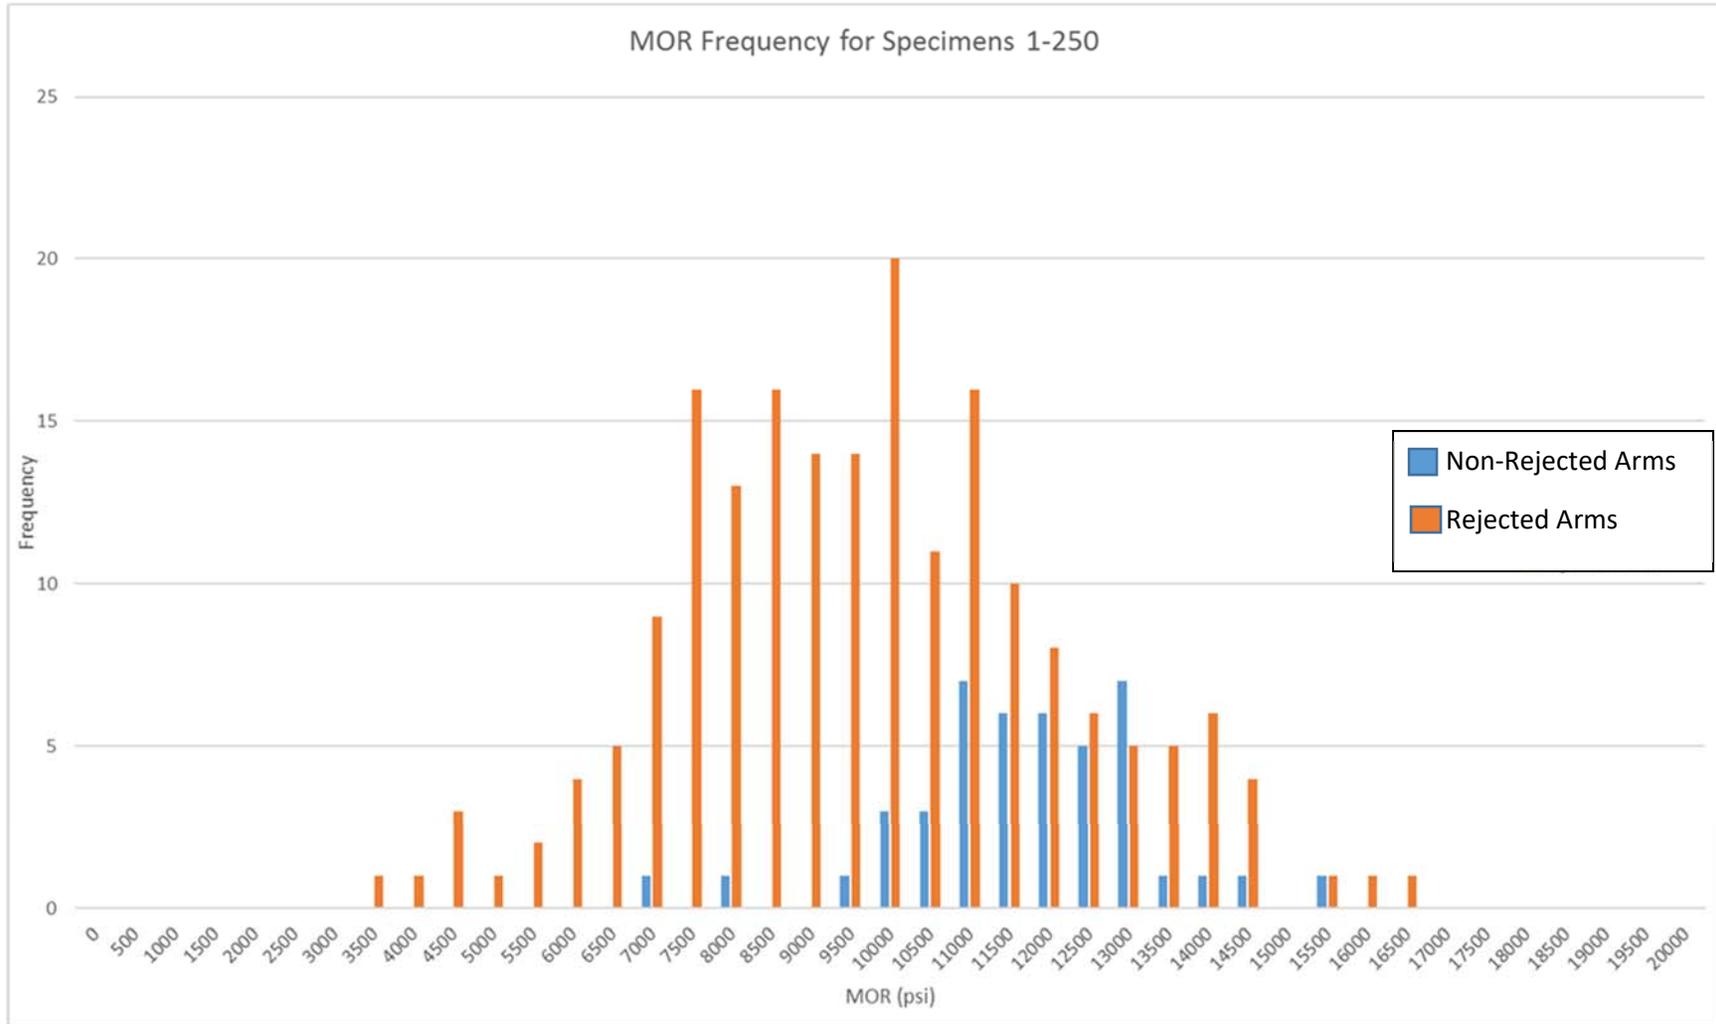
Figure III-18. Distribution of MOR values for Douglas-fir crossarms either meeting current ANSI 05.3 requirements or failing to do so because of defects.

While it is clear that many reject arms had acceptable flexural properties, this information serves little purpose if there is no way to identify these materials. Knot dimensions are a critical factor in crossarm grading, both in terms of location and dimension. Knots are an easily detected defect and are known to reduce material properties. Total knot area was poorly correlated with MOR for both acceptable and reject arms (Figure III-21). However, it is important to note that total knot area includes knots on all four sides of the arm, while MOR is most heavily affected by knots on the tension face, followed by the compression face. Knot area on the tension face and MOR were also poorly correlated, suggesting that more subtle defects were affecting crossarm properties.
