Oregon State University Utility Pole Research Cooperative (UPRC)

**Department of Wood Science & Engineering
38th Annual Report
2018**

**By:
Jed Cappellazzi and Matt Konkler**

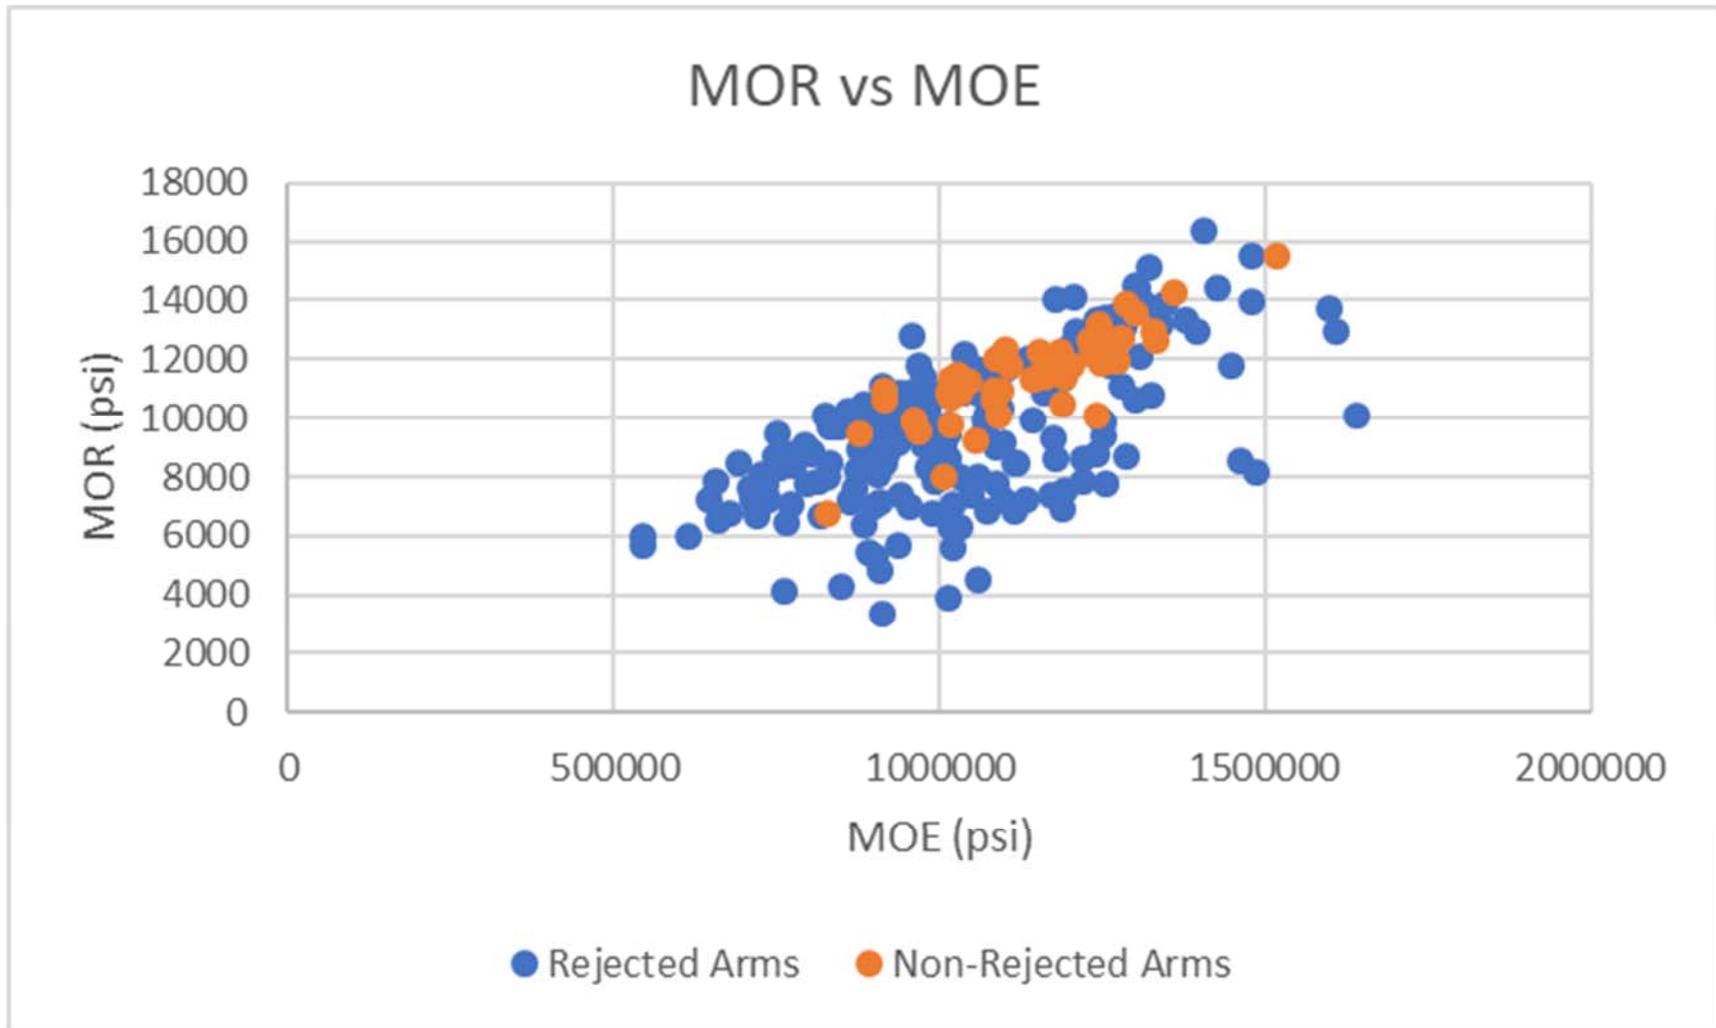
Figure III-19. MOR vs MOE for Douglas-fir crossarms either meeting current ANSI 05.3 requirements or failing to do so because of defects.

While it is clear that many reject arms had acceptable flexural properties, this information serves little purpose if there is no way to identify these materials. Knot dimensions are a critical factor in crossarm grading, both in terms of location and dimension. Knots are an easily detected defect and are known to reduce material properties. Total knot area was poorly correlated with MOR for both acceptable and reject arms (Figure III-21). However, it is important to note that total knot area includes knots on all four sides of the arm, while MOR is most heavily affected by knots on the tension face, followed by the compression face. Knot area on the tension face and MOR were also poorly correlated, suggesting that more subtle defects were affecting crossarm properties.

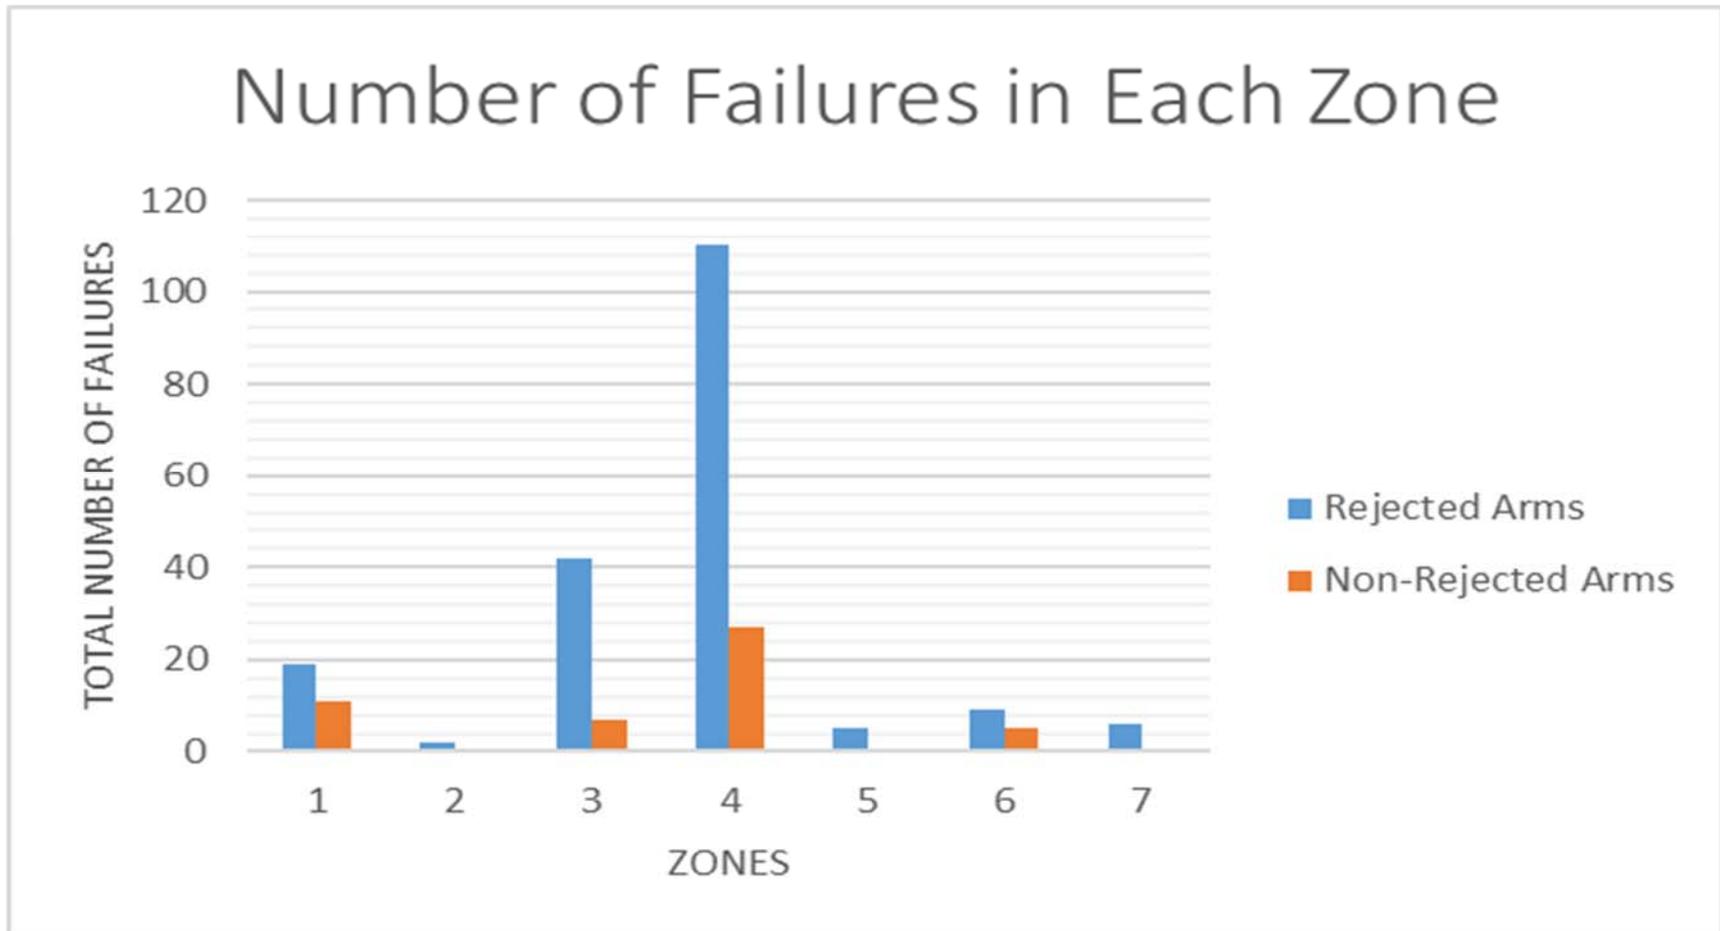
Figure III-20. Failure locations on Douglas-fir crossarms either meeting current ANSI 05.3 requirements or failing to do so because of defects.

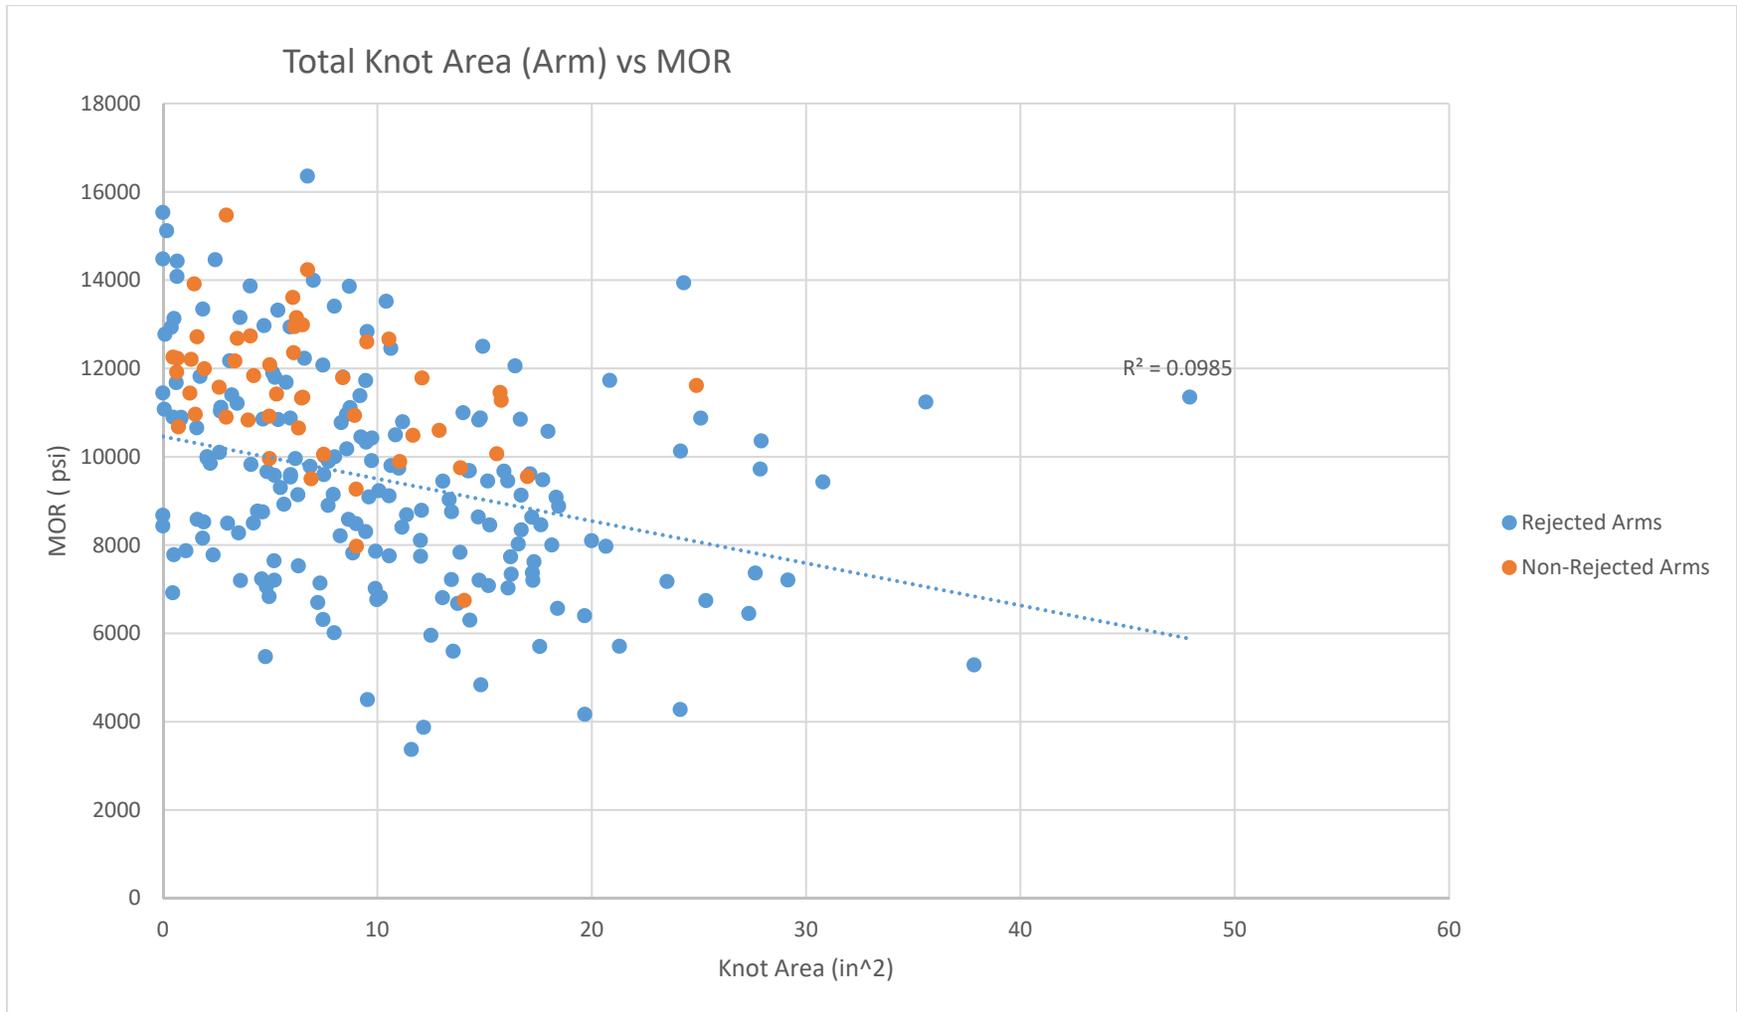
Figure III-21. Relationship between total knot area and MOR for acceptable and reject Douglas-fir crossarms.

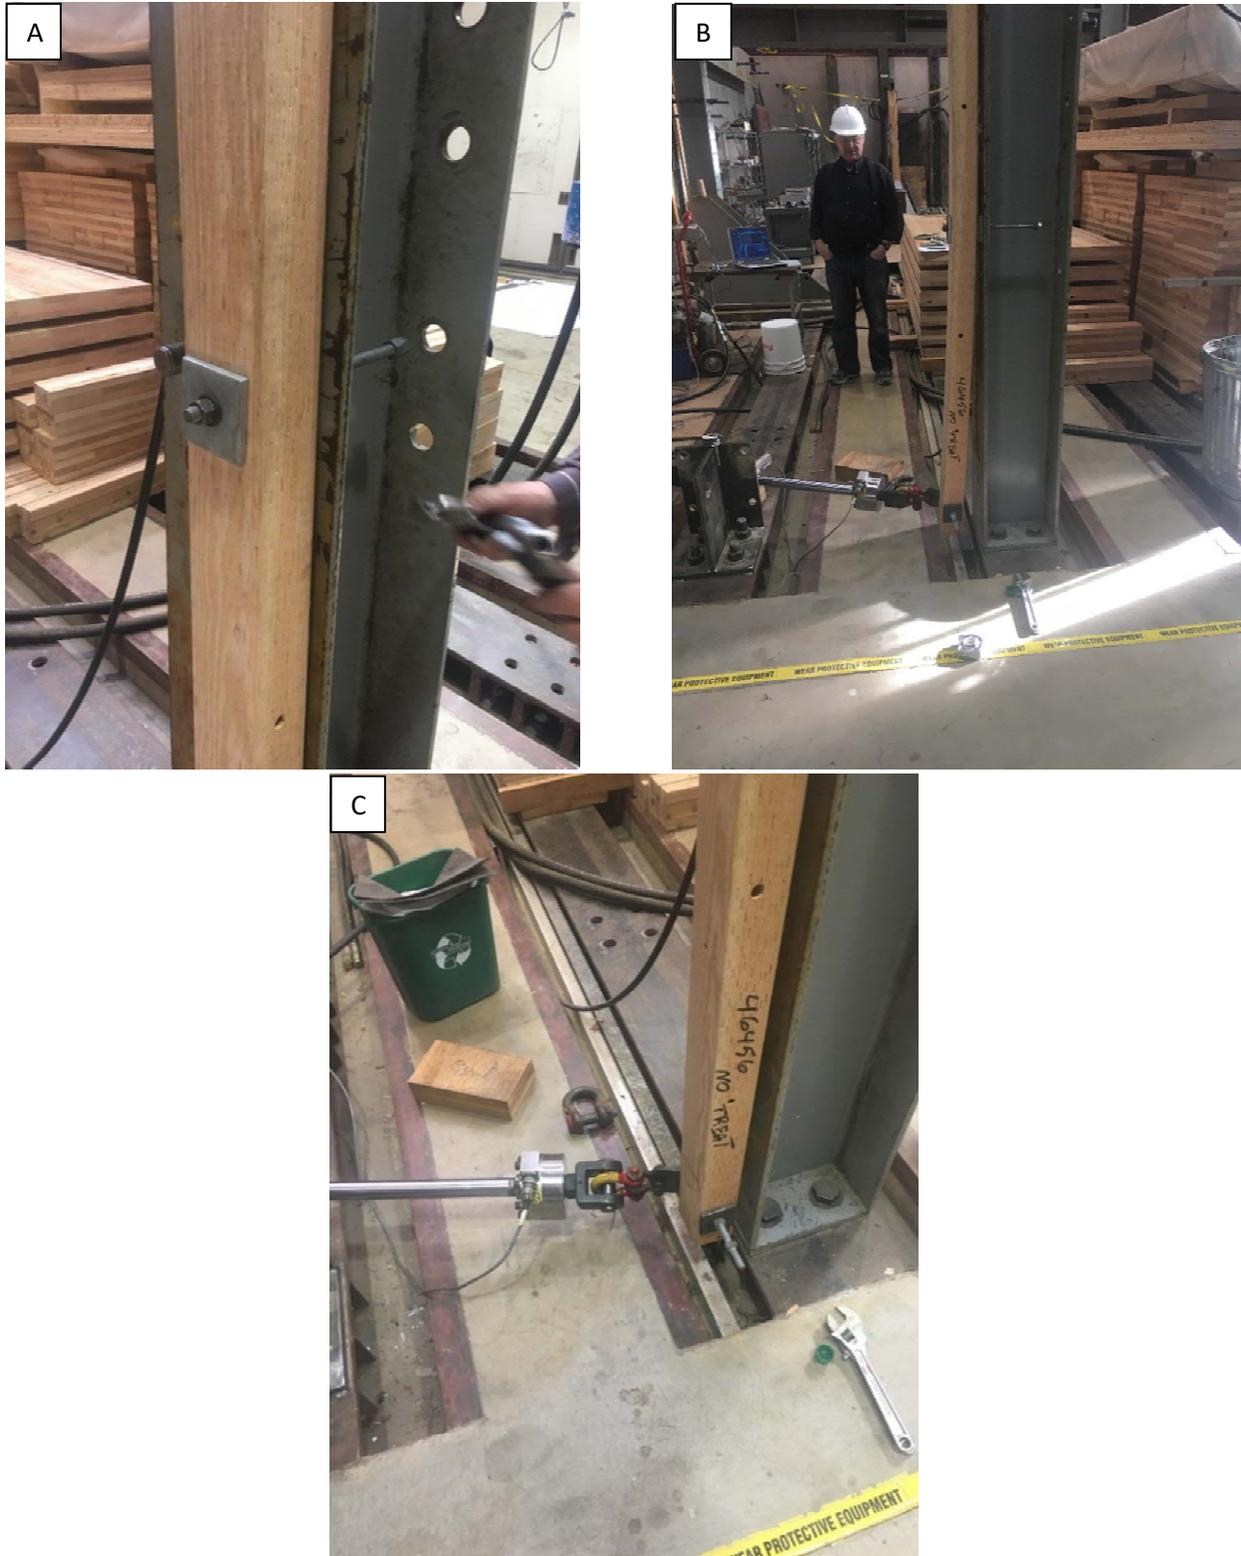
Figure III-22. Photos of the test set up used to assess crossarm properties showing: A) an arm bolted to the steel bracket, B) an arm showing deflection under load as it is tested, and C) the hydraulic rod used to pull the arm.

These data are still being analyzed to determine if various aspects of knot size, geometry, position, or other wood quality factors can be used to identify arms that might appear defective but are, in fact, capable of performing as well as, while identifying arms that are, clearly incapable of performing. These results will be presented in the 2019 annual report. For now, examples of the apparatus (Figure III-22) and various crossarm failures (Figure III-23) are presented.

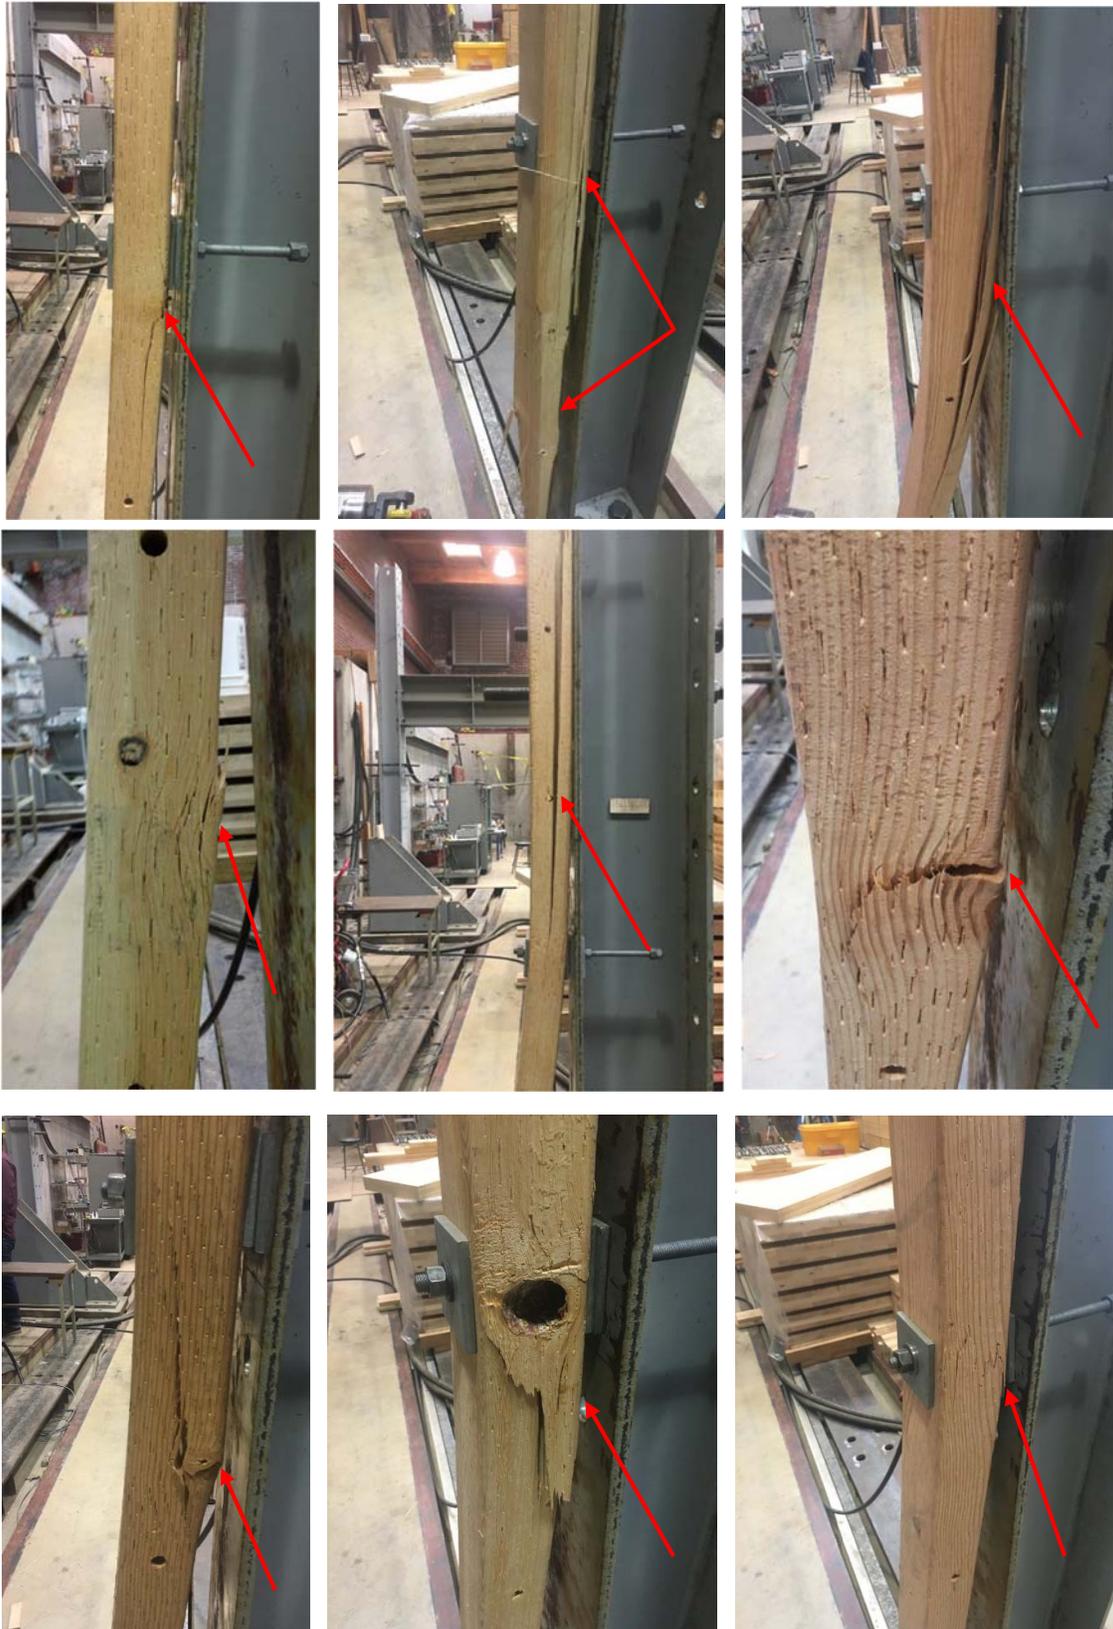
Figure III-23. Examples of crossarm failures (red arrows) following full-scale flexural testing.

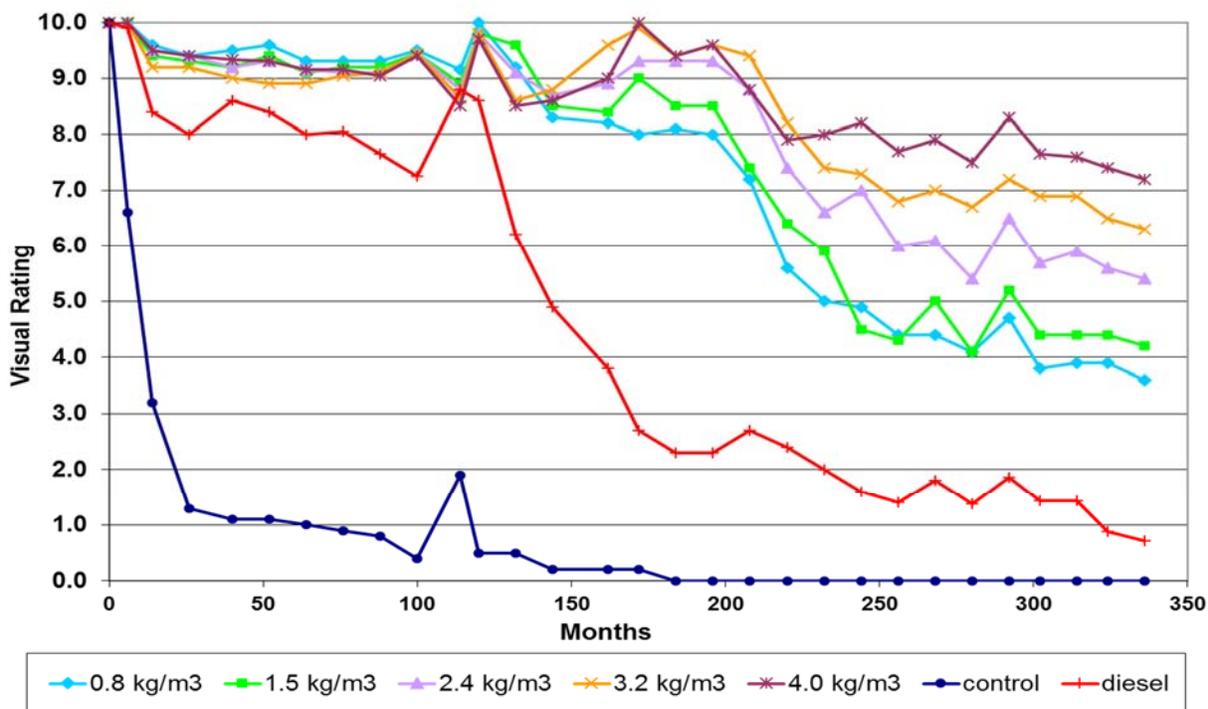
Figure V-1. Condition of freshly sawn western redcedar sapwood stakes treated with selected retentions of copper naphthenate in diesel oil and exposed in a soil bed for 336 months.

The results with freshly sawn and treated western redcedar clearly show good performance. These results are consistent with field performance of this preservative on western species. We continue to seek copper naphthenate treated Douglas-fir poles in the Northwest so that we can better assess the field performance of this system.

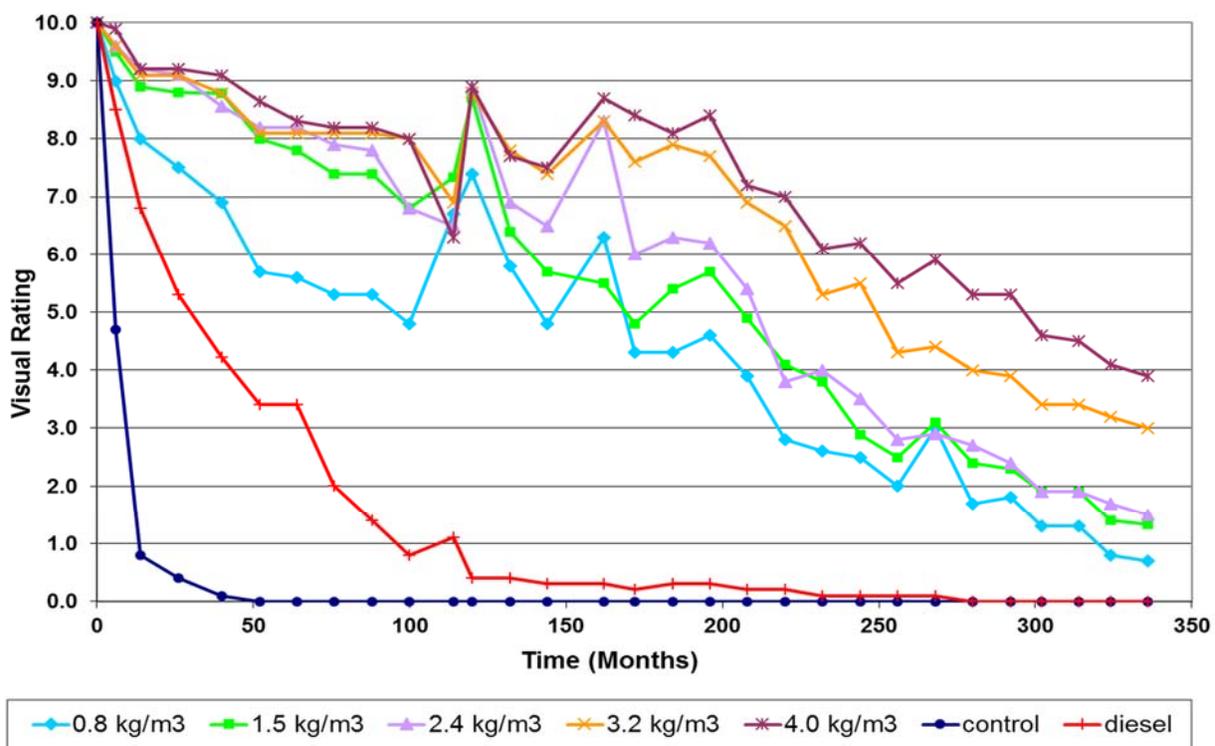
Figure V-2. Condition of weathered western redcedar sapwood stakes treated with selected retentions of copper naphthenate in diesel oil and exposed in a soil bed for 336 months.

A more reasonable approach might be to remove weathered wood and treat the poles. This process would be very similar to processes that have been used for removing sapwood on freshly peeled poles to produce a so-called “redbird” pole. Since weathered wood is already physically degraded, it likely has little strength and contributes little to overall material properties. Thus, treatment serves little practical purpose. Removal of this more permeable, weaker wood would effectively reduce the pole class, but might result in a better performing pole. Resulting treatments on shaved poles would be shallower given the resistance of western redcedar to preservative treatment, but any gaps in the treatment barrier would only expose durable heartwood.

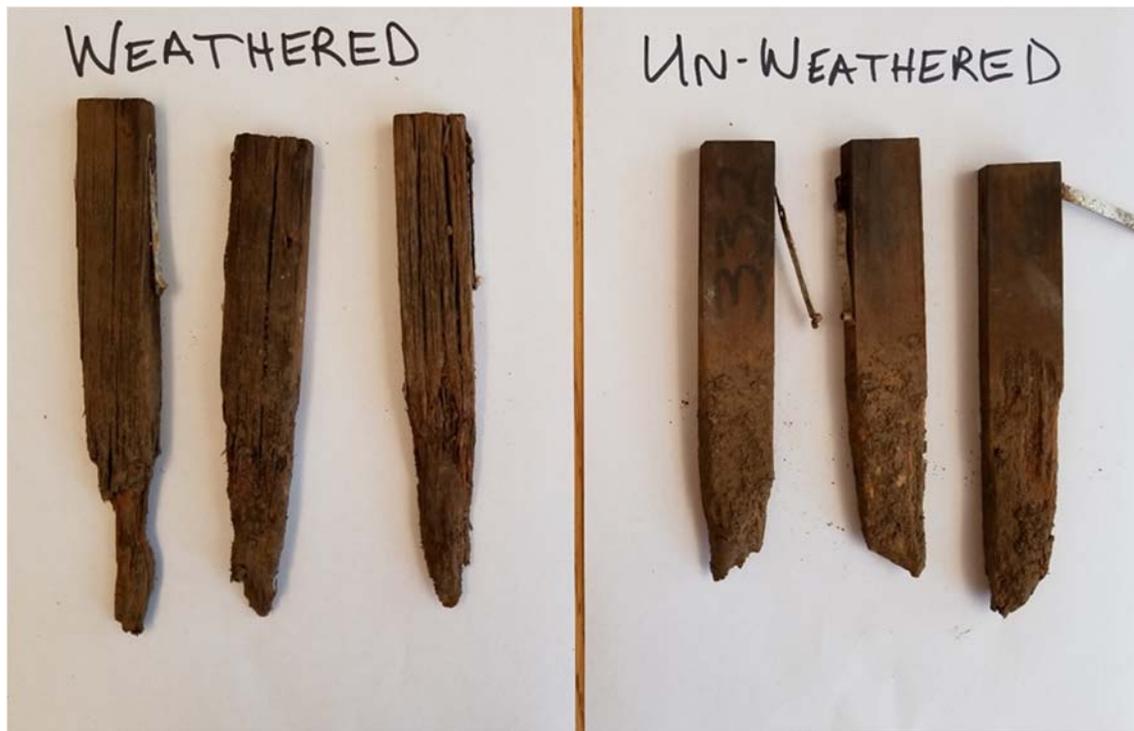
Figure V-3. Examples of western redcedar stakes cut from weathered poles and freshly sawn lumber that have failed in test showing a tendency for the wood to decay towards the lower end of the samples.
